Appendix B: Stream Restoration Sites

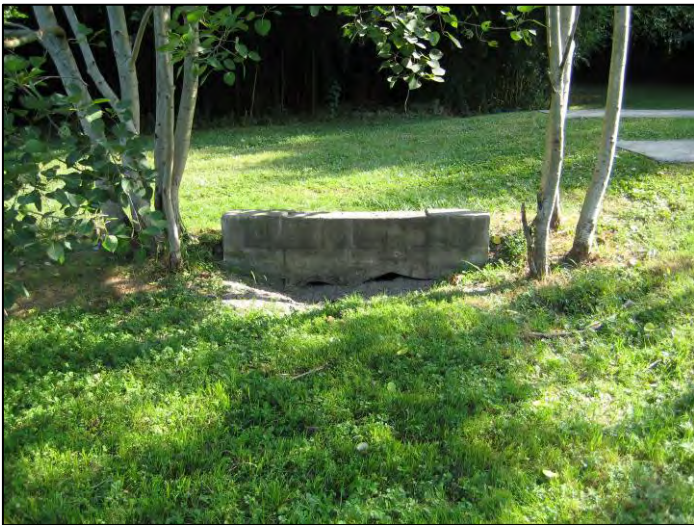
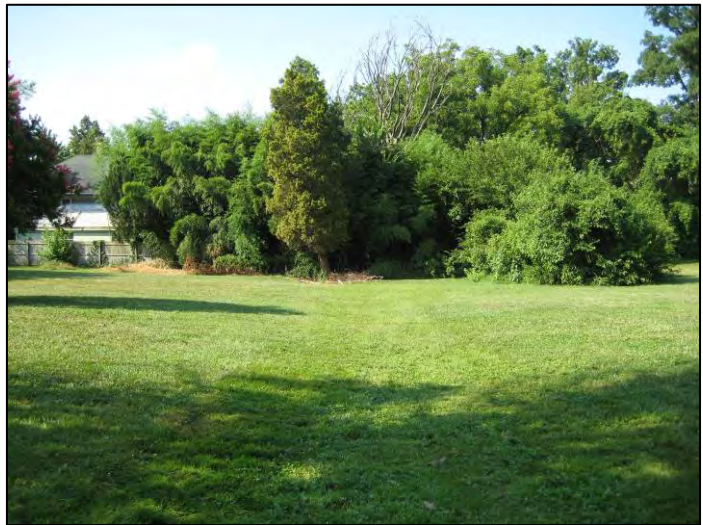
PROJECT_NUMBER	RC_Stream_01
SITE_LOCATION	Park Between Willow Street NW and Maple Street NW
ADC_MAP_LOCATION	5408_H5
OWNERSHIP	Public
APPROXIMATE_LENGTH (Feet)	252
DESCRIPTION_OF_EXISTING_CONDITIONS	Stream valley park with no stream. Over-land drainage with piped inflow and outflow at both ends of the park. 1st order ephemeral stream.
PROJECT_DESCRIPTION	Daylight the stream and reintroduce ground water from bioretention and rain gardens on private property, repair inflow and outflow pipes.
ESTIMATED_COST	\$188,978.00
PROJECT_RANKING_EDUCATION	Medium
PROJECT_RANKING_ENVIRONMENT	High
PROJECT_RANKING_INSTALLATION	High

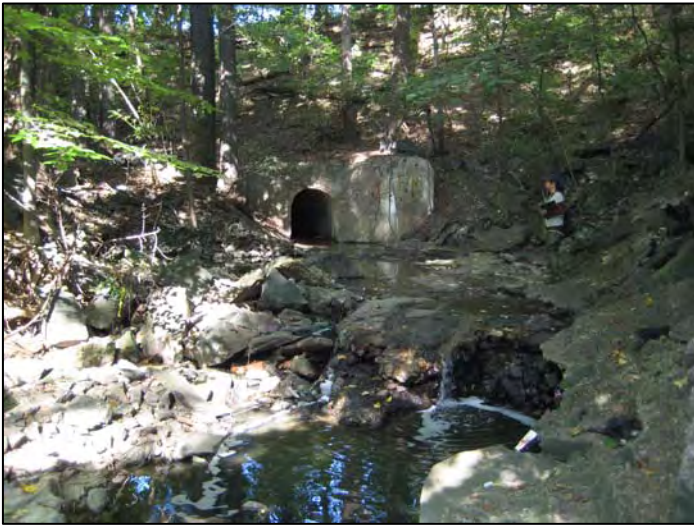
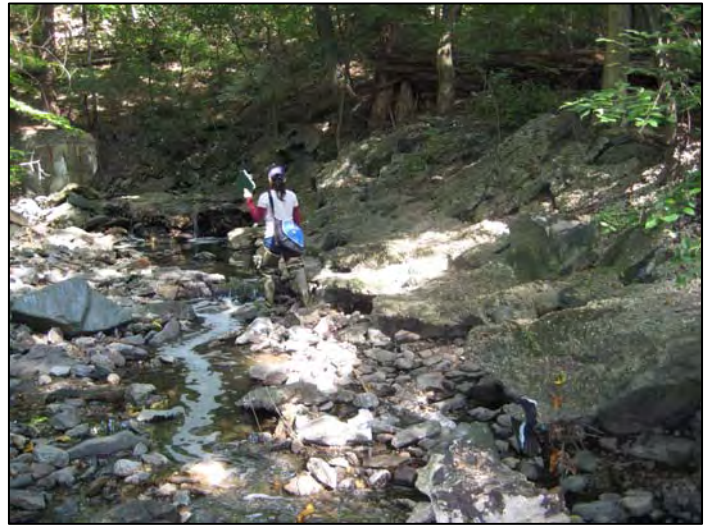
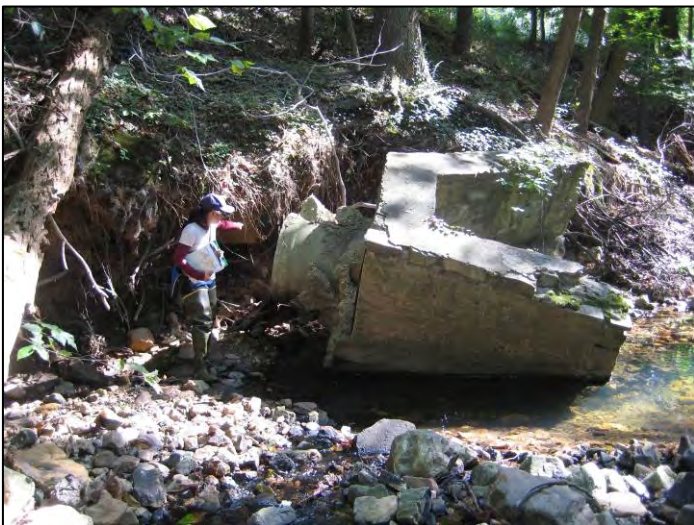
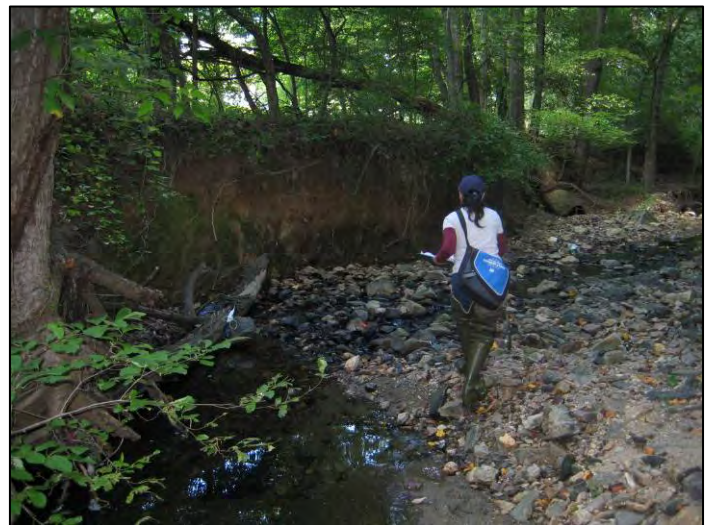
PROJECT_NUMBER	RC_Stream_03
SITE_LOCATION	Portal Branch - Between North Portal NW and South Portal NW
ADC_MAP_LOCATION	5408_D2
OWNERSHIP	Public
APPROXIMATE_LENGTH (Feet)	2351
DESCRIPTION_OF_EXISTING_CONDITIONS	Deeply incised stream from outfall where comes above ground to mouth at Rock Creek. Several collapsed outfalls sending stormwater into stream. Exposed sewer line adjacent to stream.
PROJECT_DESCRIPTION	Bioretention & regenerative stormwater conveyances for outfalls. Invasive removal and riparian buffer planting. Likely need for hardening banks, flow diversion to protect sewer infrastructure. Comprehensive work for length of stream.
ESTIMATED_COST	\$2,351,120.00
PROJECT_RANKING_EDUCATION	Low
PROJECT_RANKING_ENVIRONMENT	High
PROJECT_RANKING_INSTALLATION	High

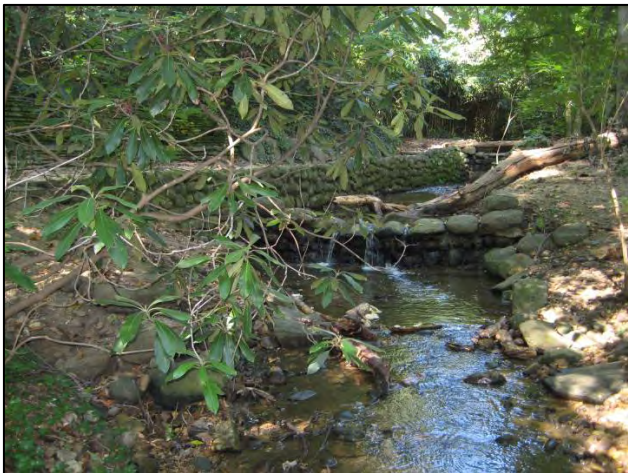
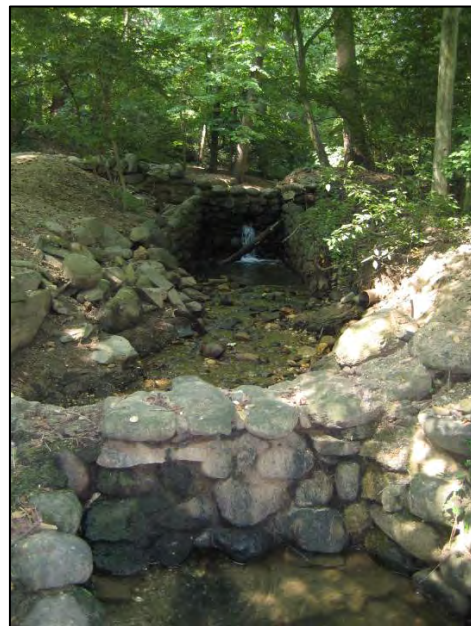
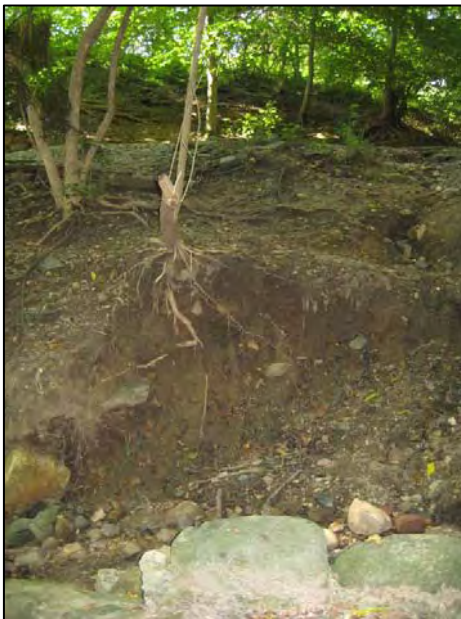
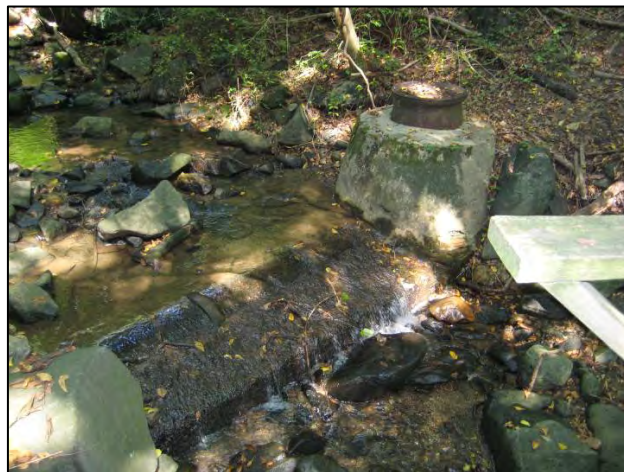
RC_Stream_04

Small first order stream with some incised banks at up stream end and greater erosion downstream of Lover's Lane NW. Many blockages to fish passage and hardened banks.

Invasive removal and riparian buffer planting. Remove fish blockages and hardened banks. Close/repair pathways to reduce erosion and control stormwater. Comprehensive work for length of stream. Flow diversion to protect sewer infrastructure near mouth.

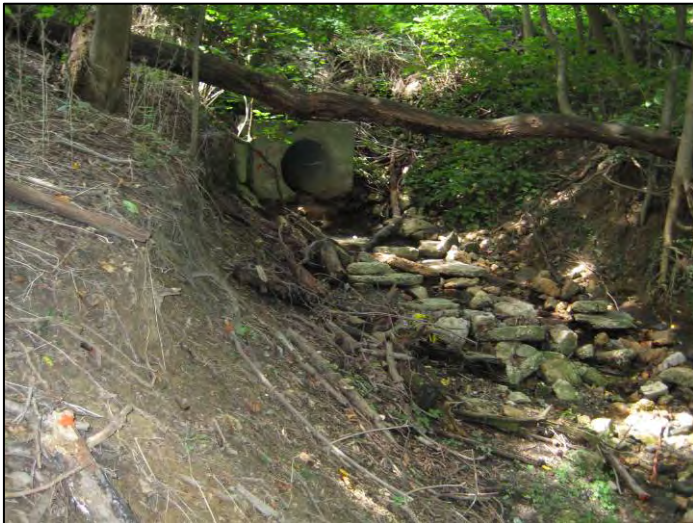
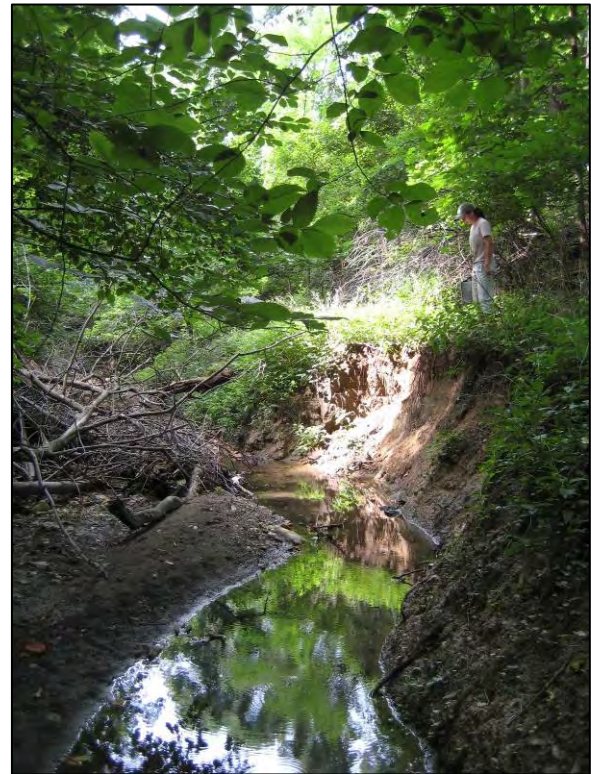
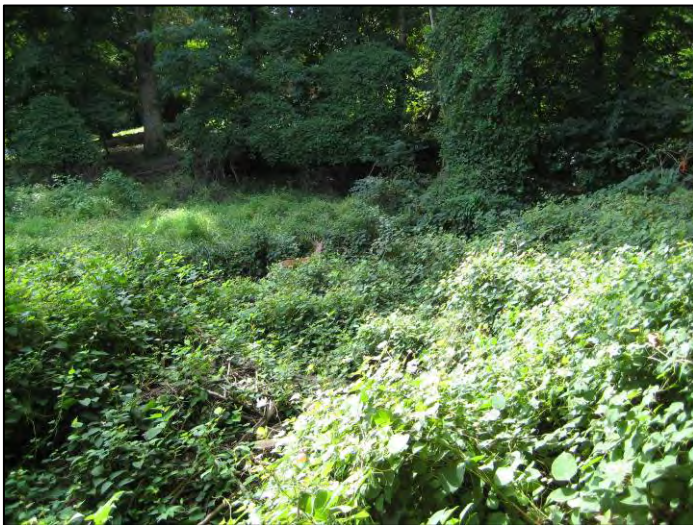
PROJECT_NUMBER	RC_Stream_05
SITE_LOCATION	Linnaean Playground Park - Linnaean Road NW and Harrison Street NW
ADC_MAP_LOCATION	5407_K7
OWNERSHIP	Public
APPROXIMATE_LENGTH (Feet)	1178
DESCRIPTION_OF_EXISTING_CONDITIONS	First order stream with moderate erosion and many invasive plants. Stream goes into a pipe at Linnaean Road NW. Some trash and fallen trees.
PROJECT_DESCRIPTION	Stream bank stabilization for length of stream. Install regenerative stormwater conveyances and/or bioretention to slow/infiltrate stormwater entering the stream valley.
ESTIMATED_COST	\$883,500.00
PROJECT_RANKING_EDUCATION	Low
PROJECT_RANKING_ENVIRONMENT	Medium
PROJECT_RANKING_INSTALLATION	High

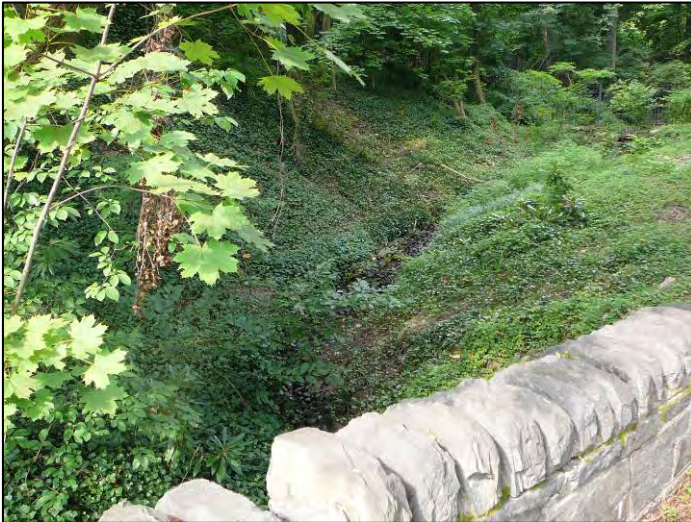
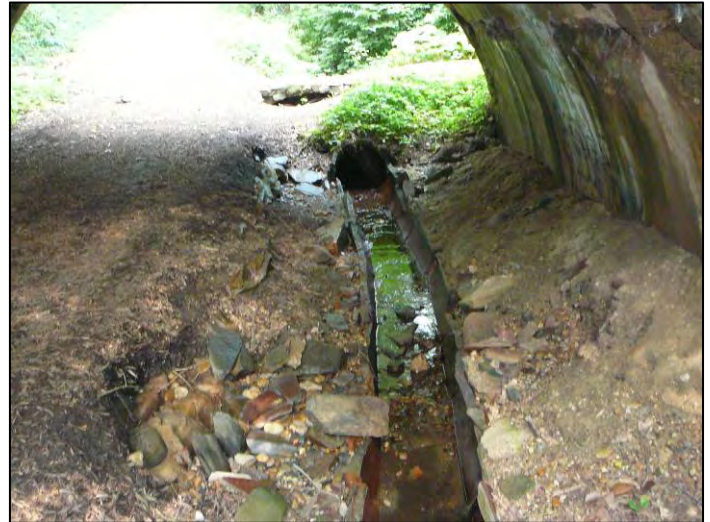
PROJECT_NUMBER	RC_Stream_06
SITE_LOCATION	Tregaron Park - Klingle Road NW and Cortland Place NW
ADC_MAP_LOCATION	5528_A2
OWNERSHIP	Private
APPROXIMATE_LENGTH (Feet)	957
DESCRIPTION_OF_EXISTING_CONDITIONS	Wooded, manicured garden open to public with a small stream flowing through the park. Stream piped in some locations and bare soil exposed in areas. Stream flows under lily pond. Stream leaves park at Klingle Road where it is directed into a culvert.
PROJECT_DESCRIPTION	Some stream bank stabilization and planting of herbaceous emergents. Potential wetland where stream flows into culvert. Remove culvert at Klingle Road, daylight stream and put a bridge over restored stream.
ESTIMATED_COST	\$718,065.00
PROJECT_RANKING_EDUCATION	High
PROJECT_RANKING_ENVIRONMENT	High
PROJECT_RANKING_INSTALLATION	Medium

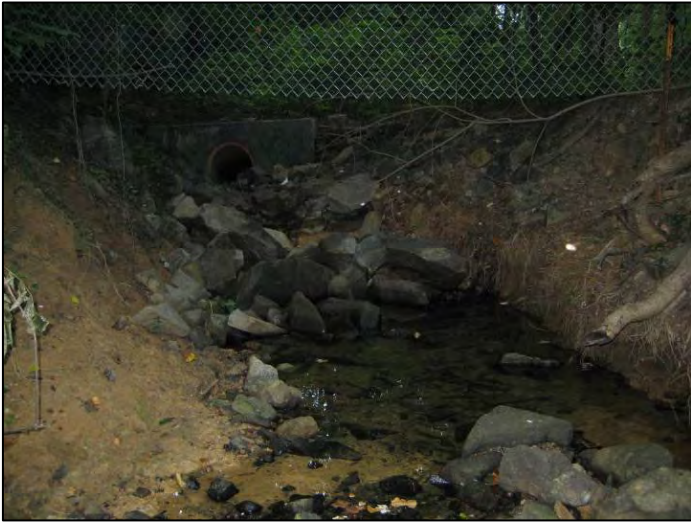
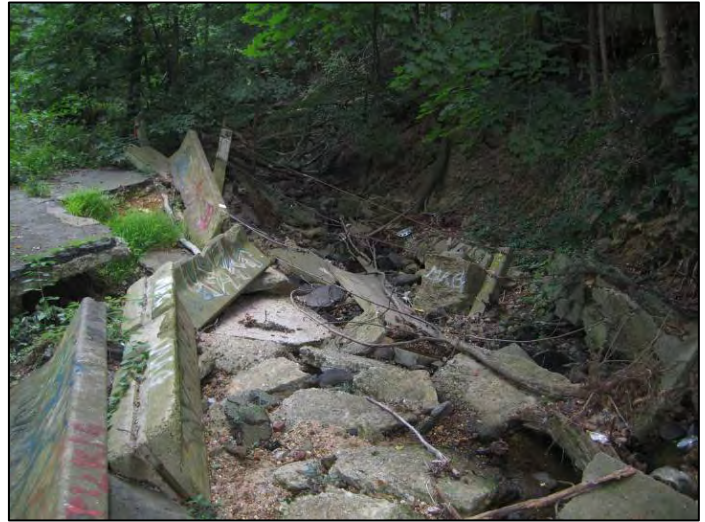
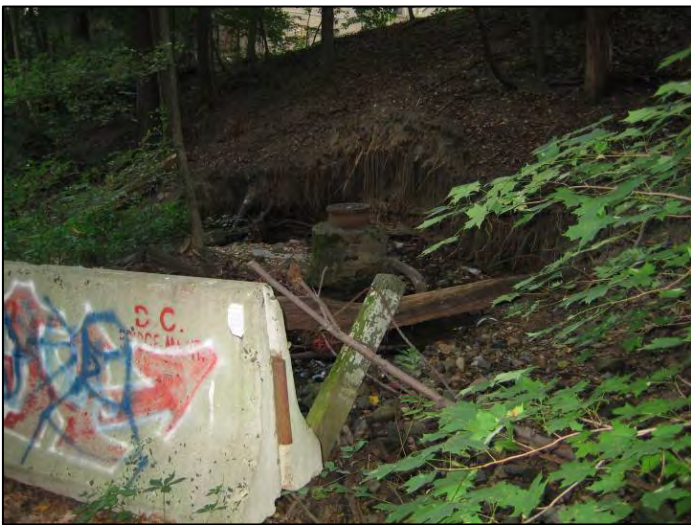
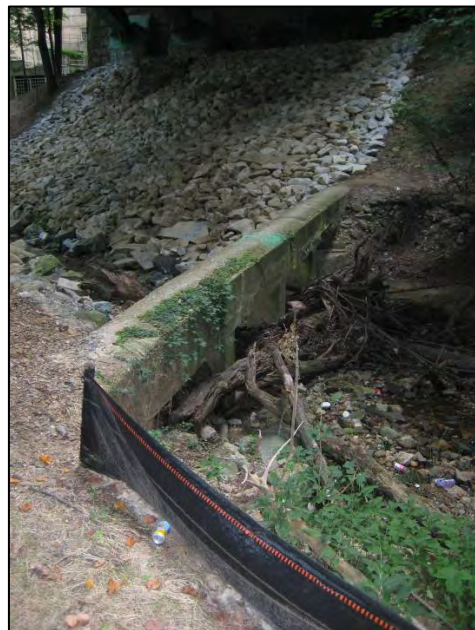
PROJECT_NUMBER	RC_Stream_07
SITE_LOCATION	Upper Klingle Run - Klingle Road NW and Cortland Place NW to Connecticut Avenue NW
ADC_MAP_LOCATION	5528_A2&A1
OWNERSHIP	Public
APPROXIMATE_LENGTH (Feet)	1192
DESCRIPTION_OF_EXISTING_CONDITIONS	Deeply incised stream from outfall where comes above ground to mouth at Rock Creek. Roadway adjacent to stream collapsing and closed. Exposed sewer line at Connecticut Ave.
PROJECT_DESCRIPTION	Remove roadway and replace with bioretention and stream restoration. Likely need for hardening banks, flow diversion to protect sewer infrastructure. Comprehensive work for length of stream.
ESTIMATED_COST	\$1,192,390.00
PROJECT_RANKING_EDUCATION	High
PROJECT_RANKING_ENVIRONMENT	High
PROJECT_RANKING_INSTALLATION	High

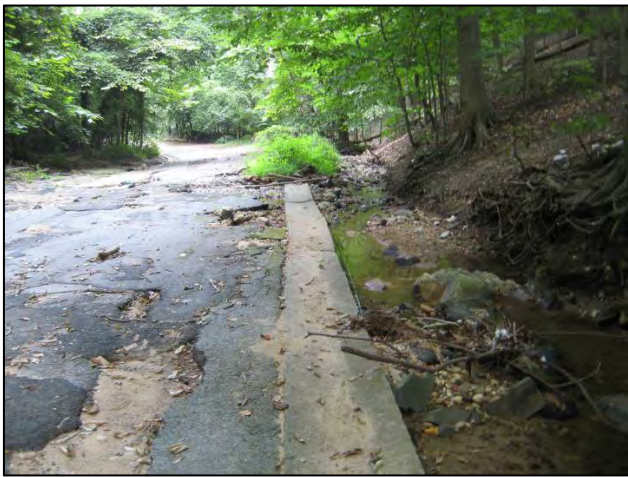
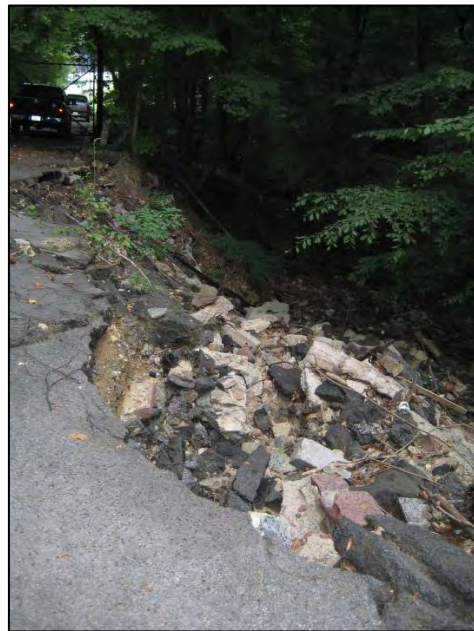
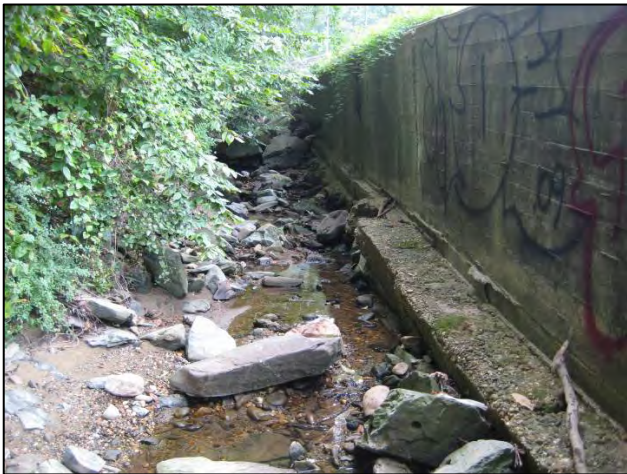
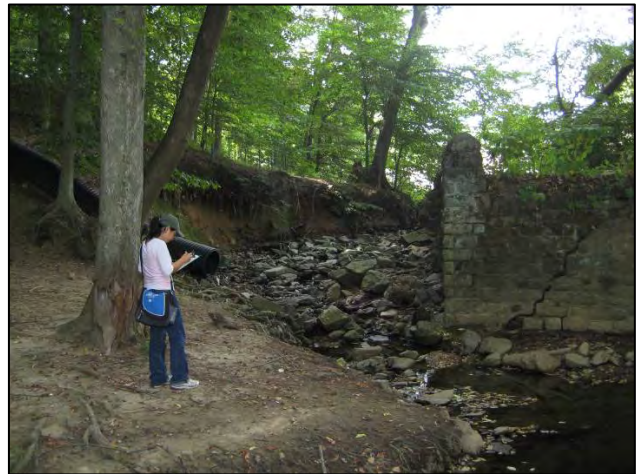
RC_Stream_08

Deeply incised stream from outfall where comes above ground to mouth at Rock Creek. Roadway adjacent to stream collapsing and closed. Channelized stream near mouth. Several roadways overly wide or unneeded at mouth of stream.

Remove roadway and replace with bioretention and stream restoration. Remove roadways at lower end of stream and make large bioretention cell. Comprehensive work for length of stream.

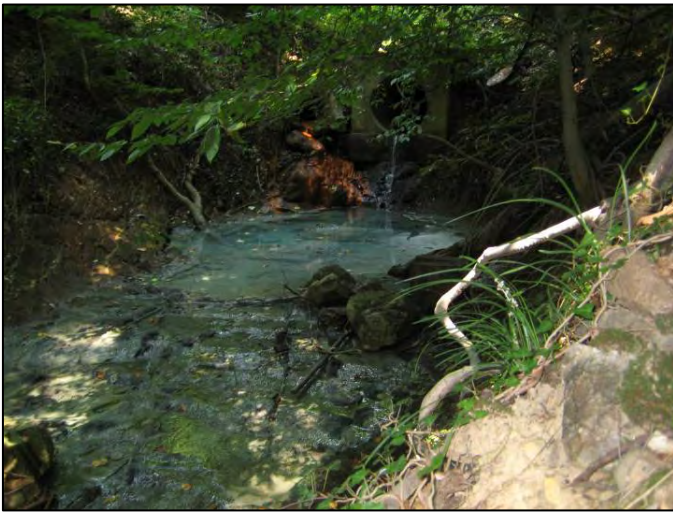
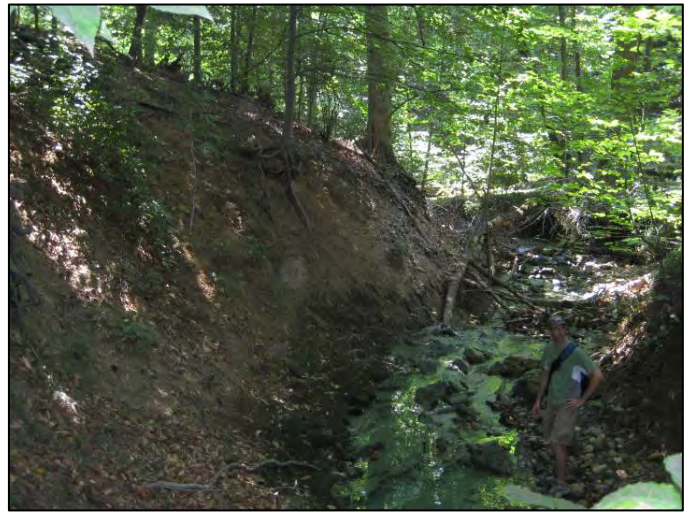
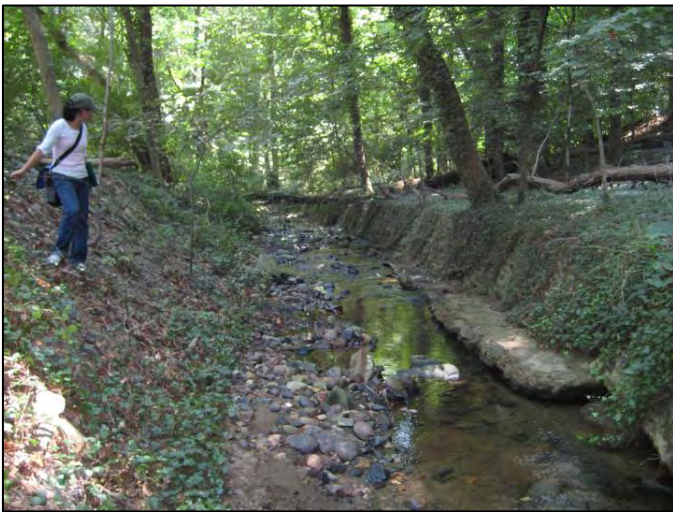
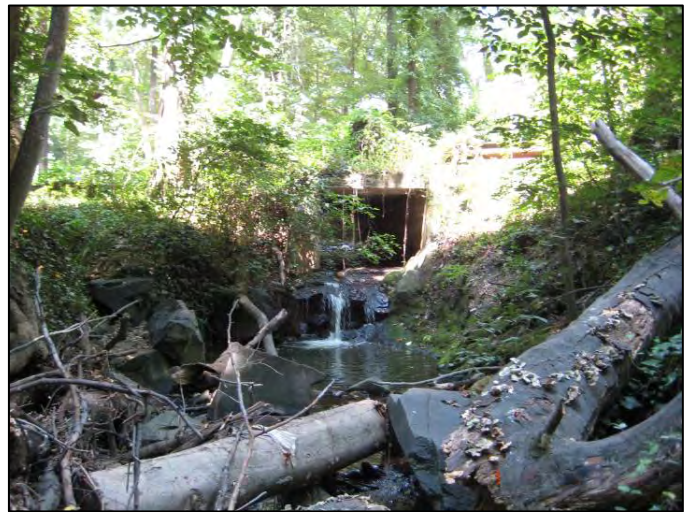
PROJECT_NUMBER	RC_Stream_09
SITE_LOCATION	Upper Normanstone Run - 34th Street NW and Garfield Street NW to 30th Street NW and Normanstone Dr
ADC_MAP_LOCATION	5527_K2&K3
OWNERSHIP	Public
APPROXIMATE_LENGTH (Feet)	2913
DESCRIPTION_OF_EXISTING_CONDITIONS	First order stream behind single family homes. Aqua discoloration at first outfall. Orange discoloration from second outfall. Stream in fair condition with points of erosion until Normanstone Drive. At this point - hardened banks, downcutting.
PROJECT_DESCRIPTION	Investigate discoloration. Correct point erosion with soft bank stabilization & flow deflection. Comprehensive stream restoration downstream of point where Normanstone Run flows next to Normanstone Drive.
ESTIMATED_COST	\$2,913,000.00
PROJECT_RANKING_EDUCATION	Medium
PROJECT_RANKING_ENVIRONMENT	High
PROJECT_RANKING_INSTALLATION	High

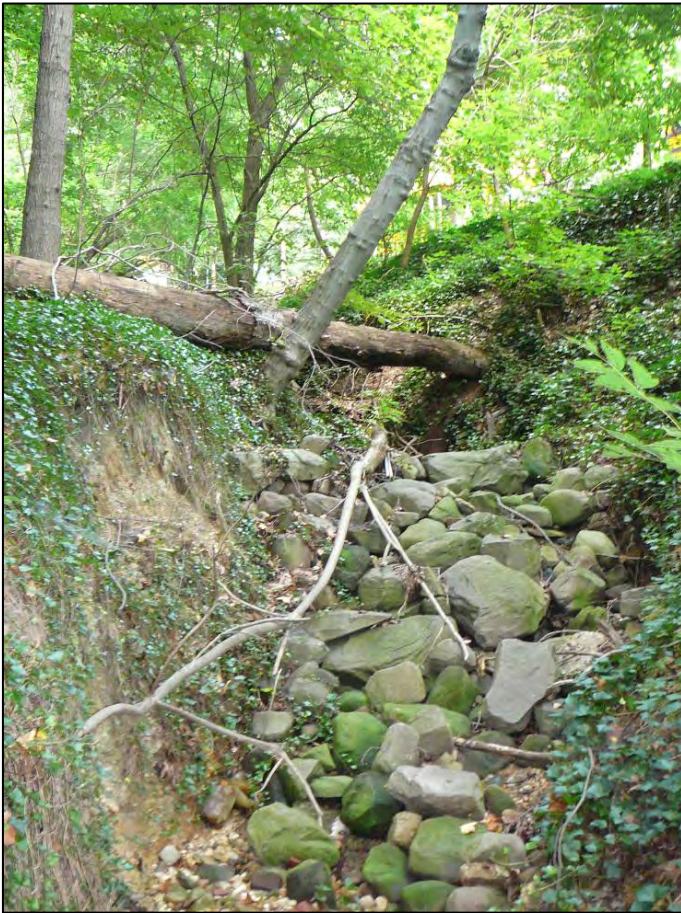
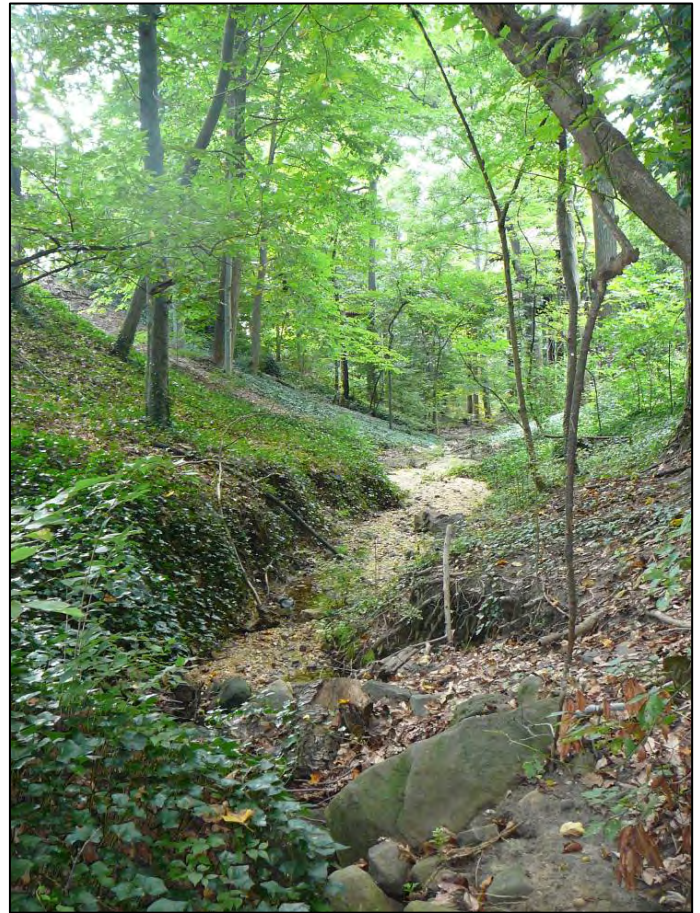
ADC_MAP_LOCATION 5527_J2&K2
OWNERSHIP Private
APPROXIMATE_LENGTH (Feet) 580
DESCRIPTION_OF_EXISTING_CONDITIONS Large wooded area with existing stream valley. Likely that stream has been piped.

PROJECT_DESCRIPTION Daylight first order stream in stream valley. Augment flow of stream with additional base flow from water infiltrated by coastal plain outfalls and bioretention for runoff from parking lot and campus roadways.

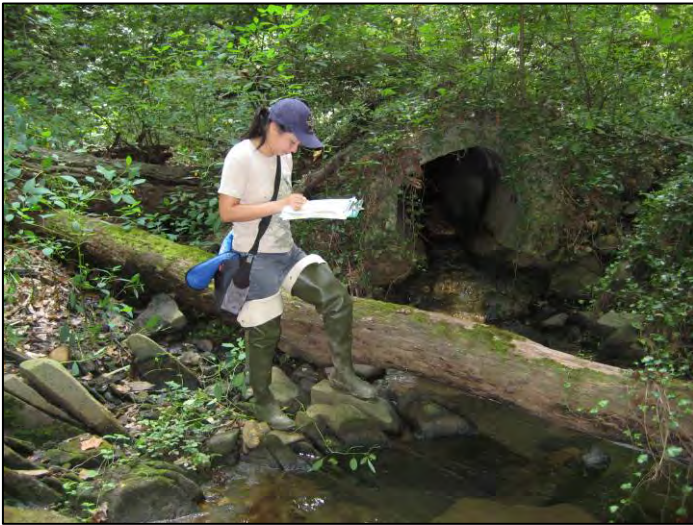
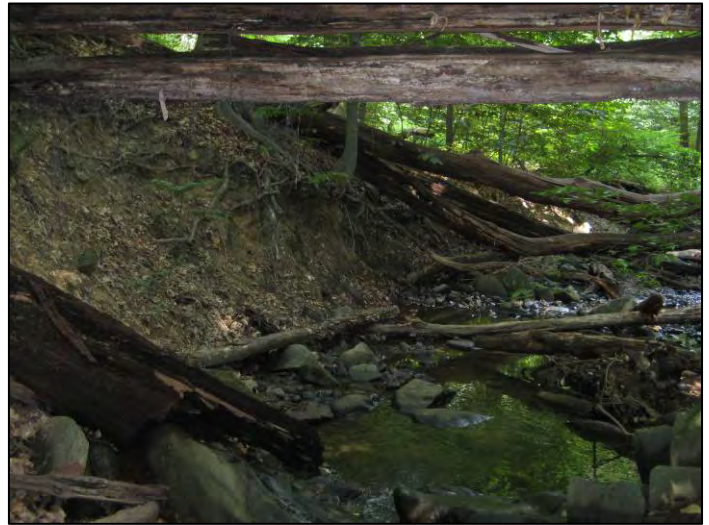
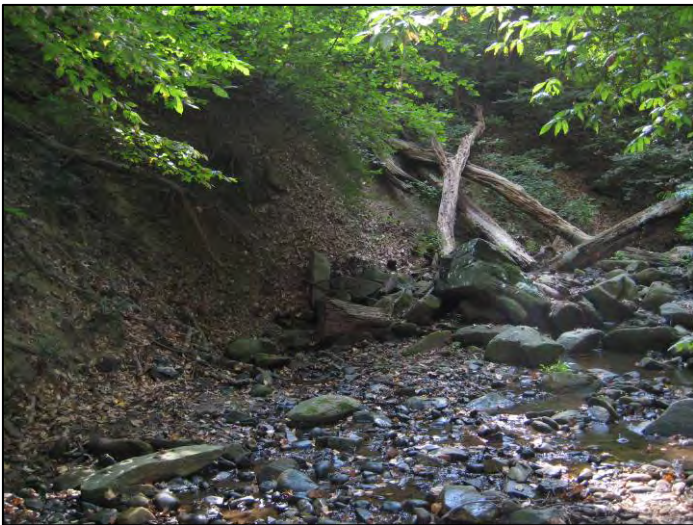
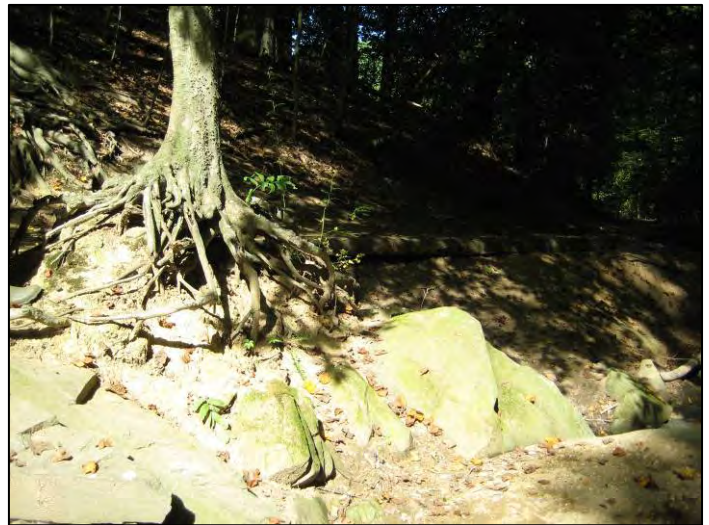
RC_Stream_13

Stream emerges from a pipe east of Connecticut Avenue. Stream banks stable until close to Rock Creek where downcutting is occurring. Paths along creek unstable and eroding into creek.

Flow deflection and bank stabilization for lower reaches of Melvin Hazen Run. Reroute pathways to discourage dogs and people from walking in stream area.

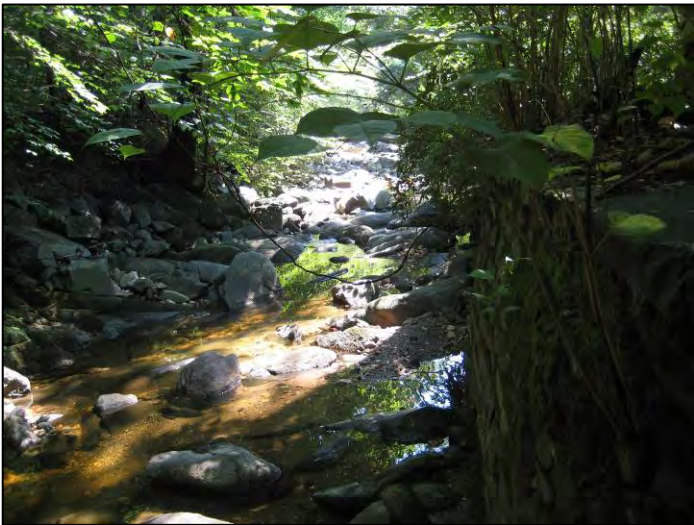
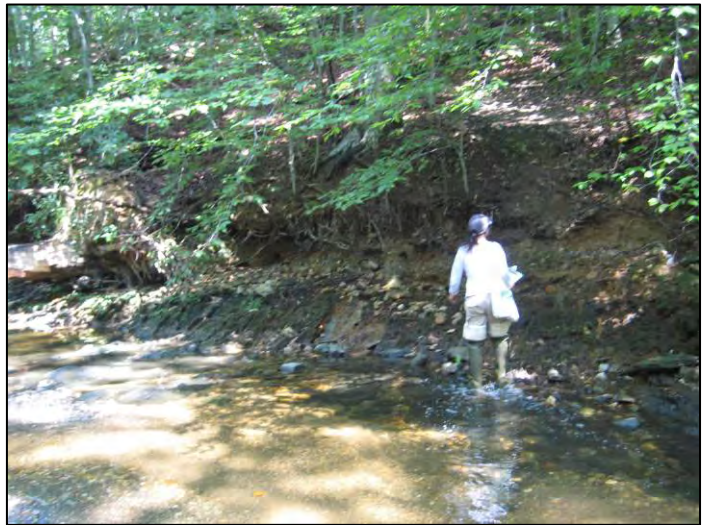
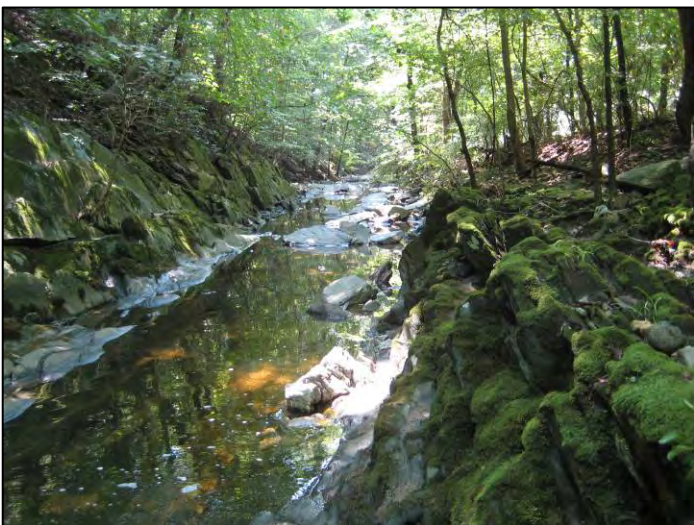
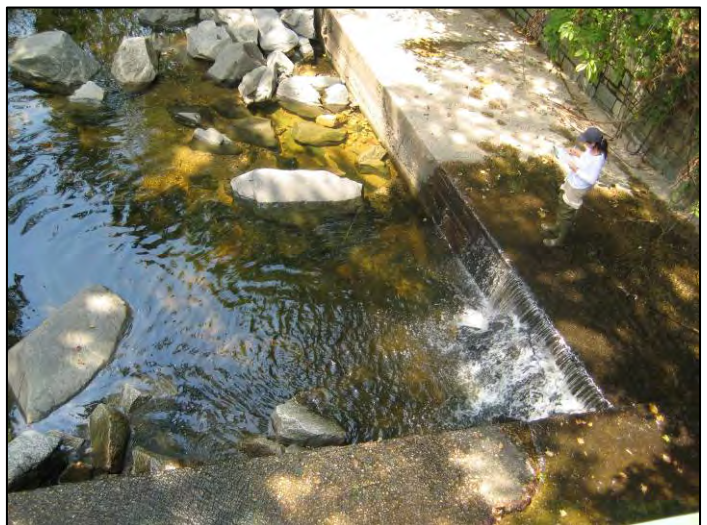
RC_Stream_15

Stream down to bedrock for length. Soft banks with erosion on wooded side opposite roadway. Hardened banks on roadside for lower reaches. Collapsing in some locations.

Bioretention & regenerative stormwater conveyances for outfalls. Invasive removal and riparian buffer planting. Likely need for hardening banks, flow diversion to protect sewer infrastructure. Comprehensive work for length of stream.

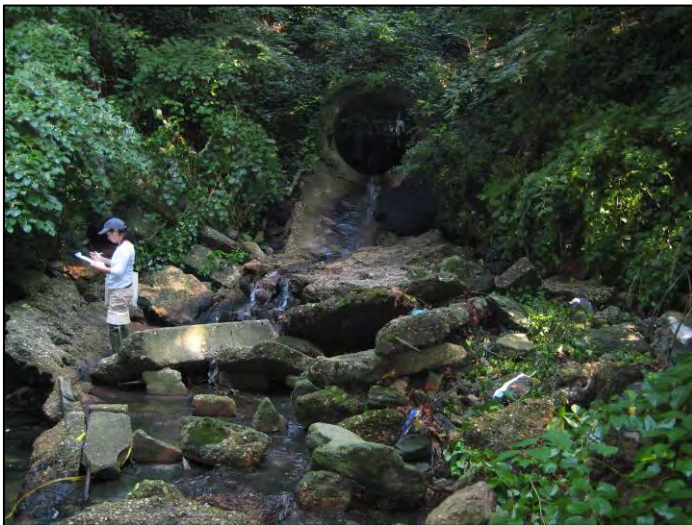
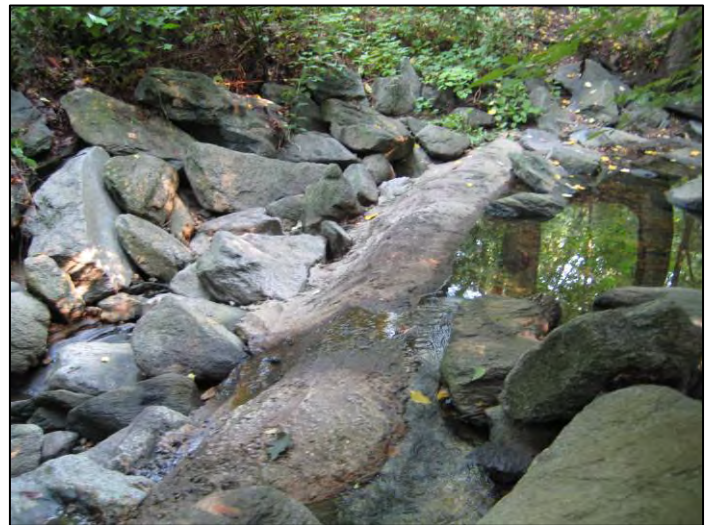
PROJECT_NUMBER	RC_Stream_16
SITE_LOCATION	Tributary to Broad Branch - Military Road NW and 31st Street NW to Broad Branch Road NW
ADC_MAP_LOCATION	5408_A7
OWNERSHIP	Public
APPROXIMATE_LENGTH (Feet)	1208
DESCRIPTION_OF_EXISTING_CONDITIONS	First order stream emerging from outfall of Military Road NW. Stream downcutting - some exposed sewer lines creating fish passage blockages.
PROJECT_DESCRIPTION	Soft bank stabilization, grade control and flow diversion structures to stabilize stream banks. Regenerative stormwater conveyance for Ingleside retirement home.
ESTIMATED_COST	\$1,208,370.00
PROJECT_RANKING_EDUCATION	Medium
PROJECT_RANKING_ENVIRONMENT	High
PROJECT_RANKING_INSTALLATION	High

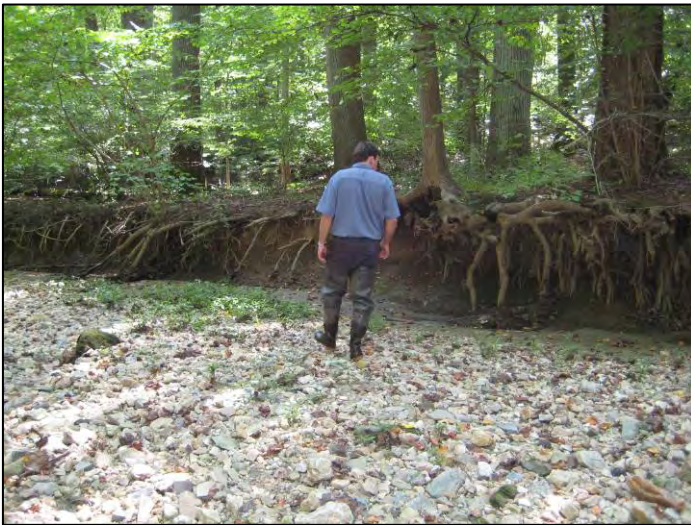
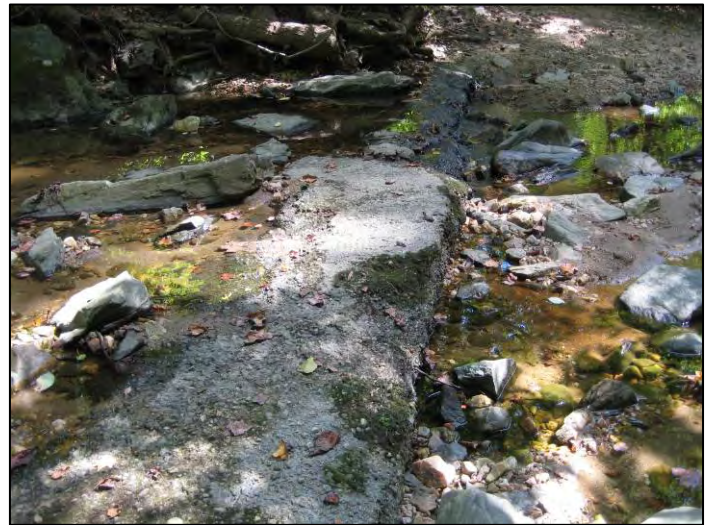
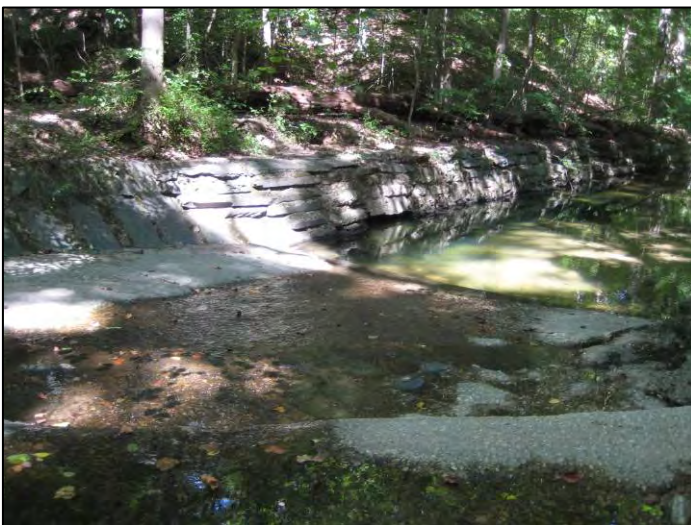
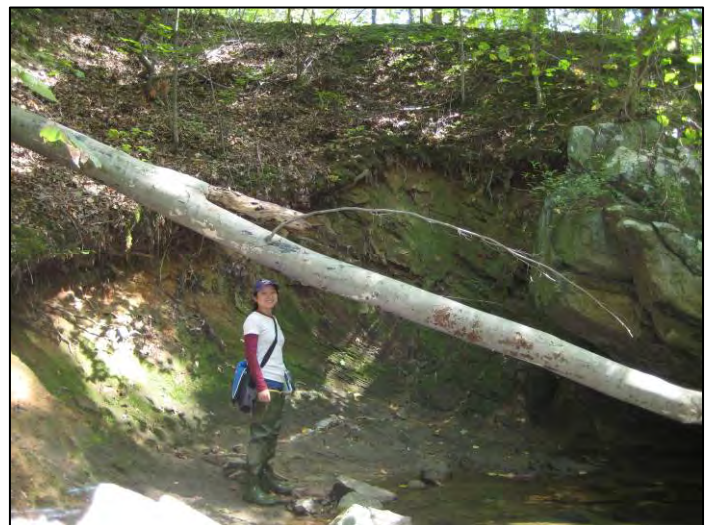
RC_Stream_23

Deeply incised stream from Oregon Avenue Bridge to Rock Creek. Undeveloped stream valley gives restoration potential however a lot of sewer infrastructure present. Some exposed sewer lines and blockages to fish passage.

Bioretention & regenerative stormwater conveyances for outfalls. Invasive removal and riparian buffer planting. Likely need for some hardening of banks, flow diversion to protect sewer infrastructure. Comprehensive work for length of stream.

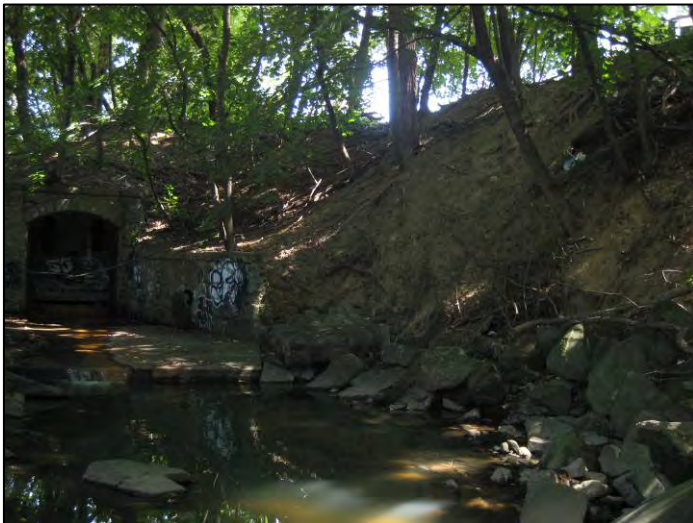
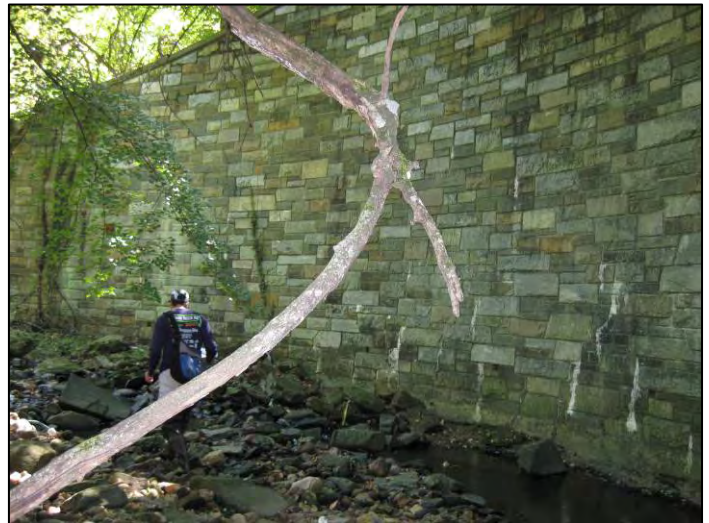
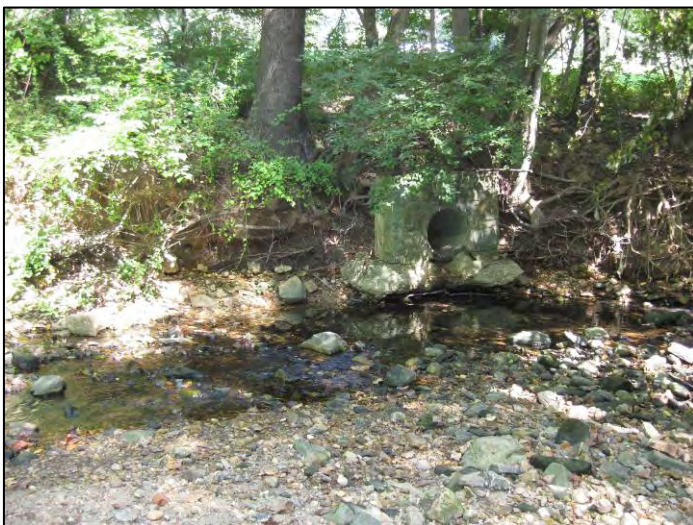
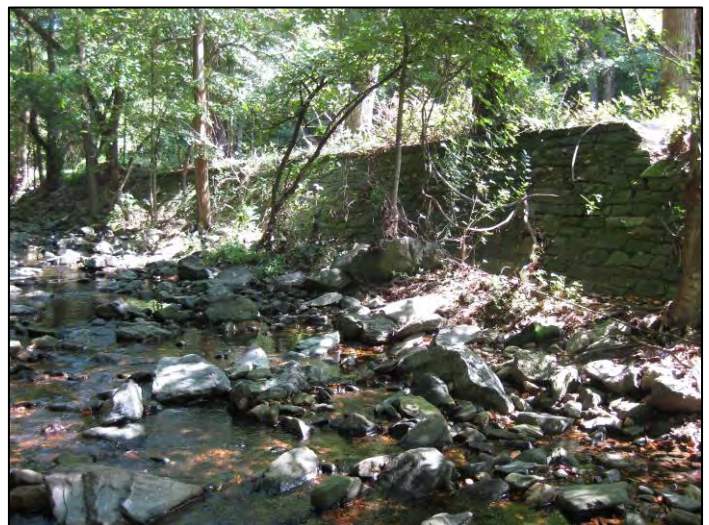
RC_Stream_24

Stream at bedrock from where comes above ground at Joyce Road NW and 16th Street NW to mouth at Rock Creek. Mix of soft banks with erosion and hardened banks protecting roadway infrastructure. Need for buffer. Several outfalls into stream.

Bioretention & regenerative stormwater conveyances for outfalls. Invasive removal and riparian buffer planting. Reengineer hardened banks, flow diversion to protect roadway & sewer infrastructure. Comprehensive work for length of stream.

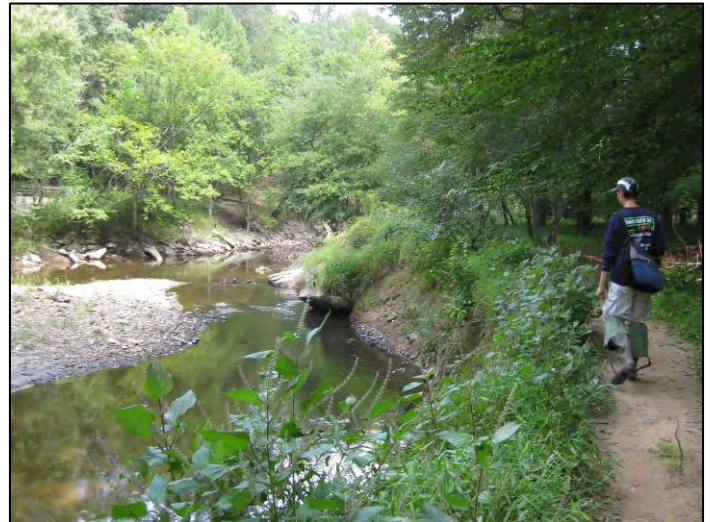
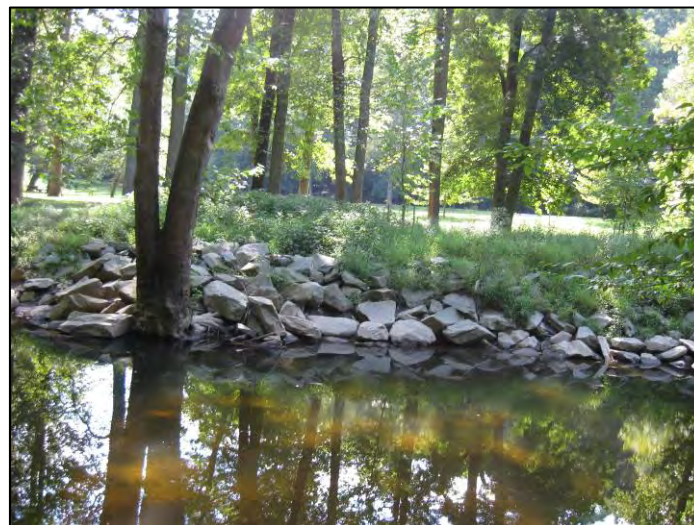
PROJECT_NUMBER	RC_Stream_25
SITE_LOCATION	Rock Creek main stem - Wise Road NW to Old Military Road NW
ADC_MAP_LOCATION	5408_C4toC7
OWNERSHIP	Public
APPROXIMATE_LENGTH (Feet)	11362
DESCRIPTION_OF_EXISTING_CONDITIONS	Forested stream valley with 2-lane road adjacent to stream for length of stream segment. Stream has mix of hardened bank structures and soft banks. Soft banks often show downcutting. Storm and sewer infrastructure present in stream valley.
PROJECT_DESCRIPTION	Comprehensive stream restoration with a mix of hard and soft structures and flow diversion devices to protect infrastructure. Planting of stream banks with deep rooted vegetation.
ESTIMATED_COST	\$8,521,402.00
PROJECT_RANKING_EDUCATION	High
PROJECT_RANKING_ENVIRONMENT	High
PROJECT_RANKING_INSTALLATION	High

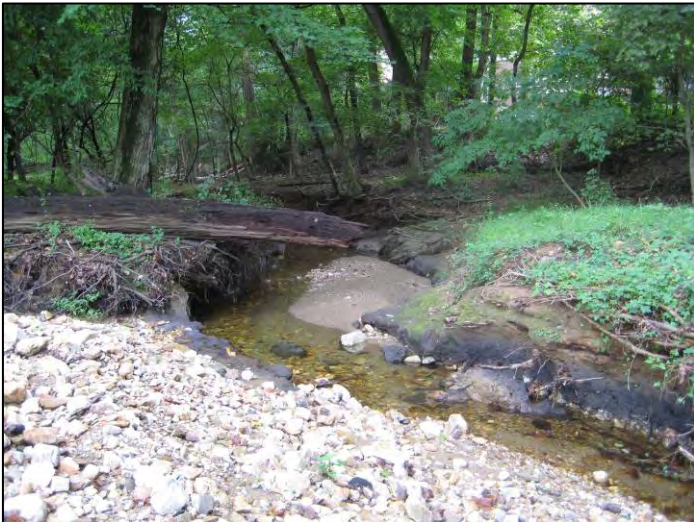
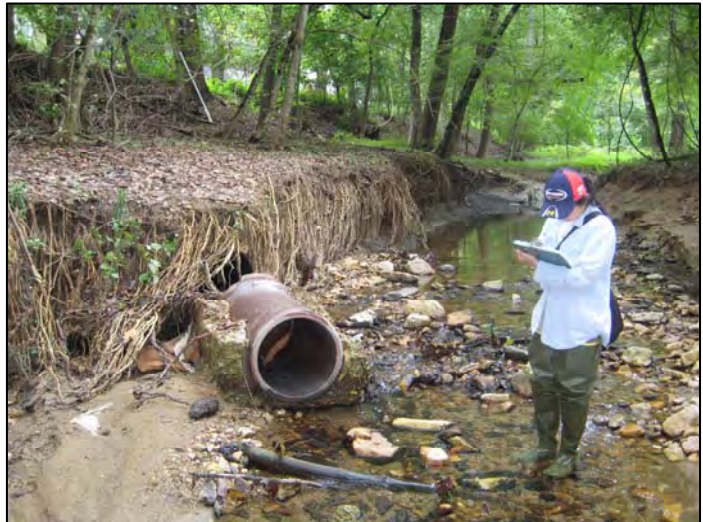
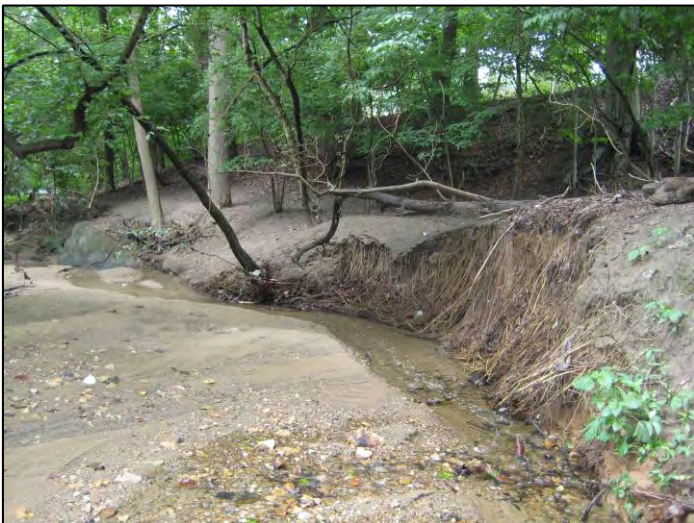
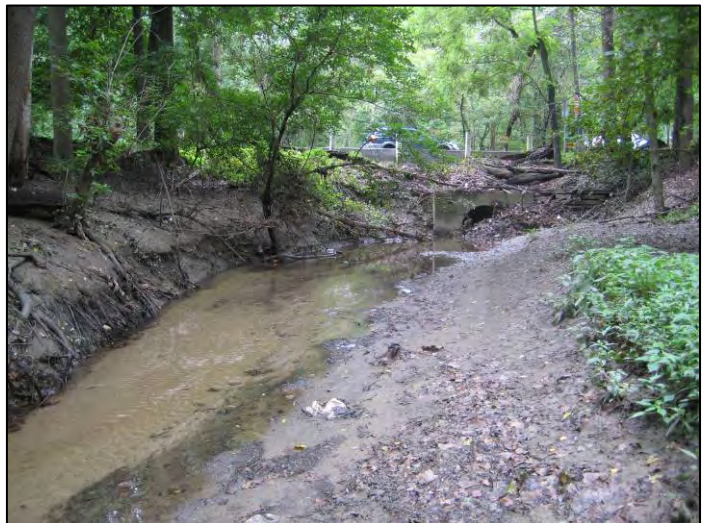
RC_Stream_28

Sediment from upstream Fenwick Branch settling north of Kalmia Street Bridge. Culvert under bridge undersized and clogged. Sediment in stream on top of clay base layer.

Redesign culvert under bridge to properly size it for flow. Potentially create wetland area upstream of bridge if won't create flooding problem. If so, remove sediment and use in upstream regenerative stormwater conveyances.

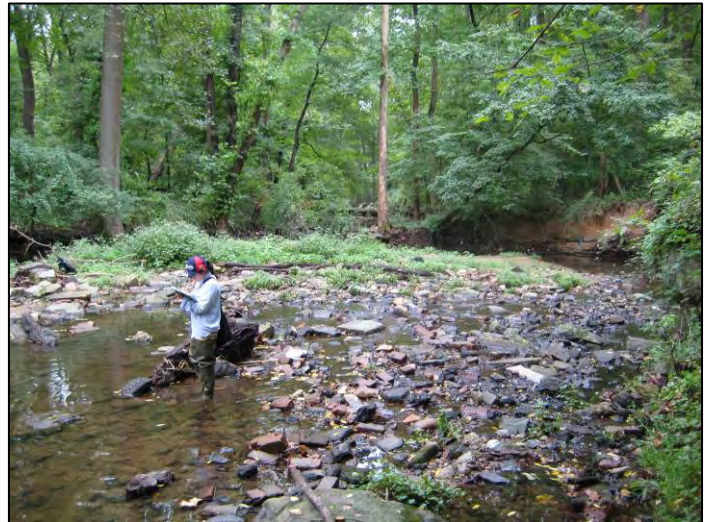
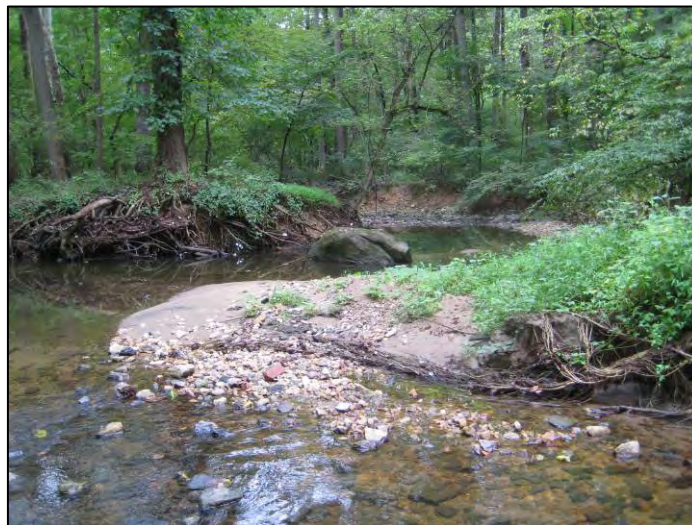
RC_Stream_29

Deeply incised stream with no current stabilization measures in place. Stream valley is wide but large amounts of stormwater from MD may limit restoration. Kalmia Bridge culvert blocks fish passage.

Bioretention & regenerative stormwater conveyances for outfalls. Invasive removal and riparian buffer planting. Likely need for hardening banks, flow diversion to protect sewer & road infrastructure. Comprehensive work for length of stream.
