Appendix B: Stream Restoration Sites

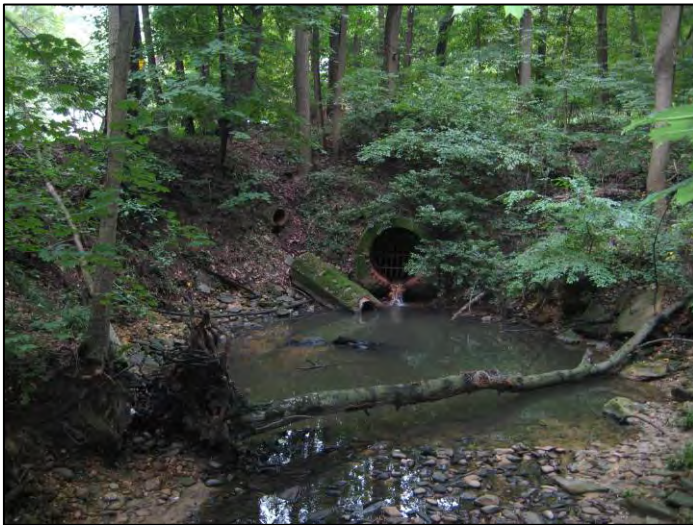
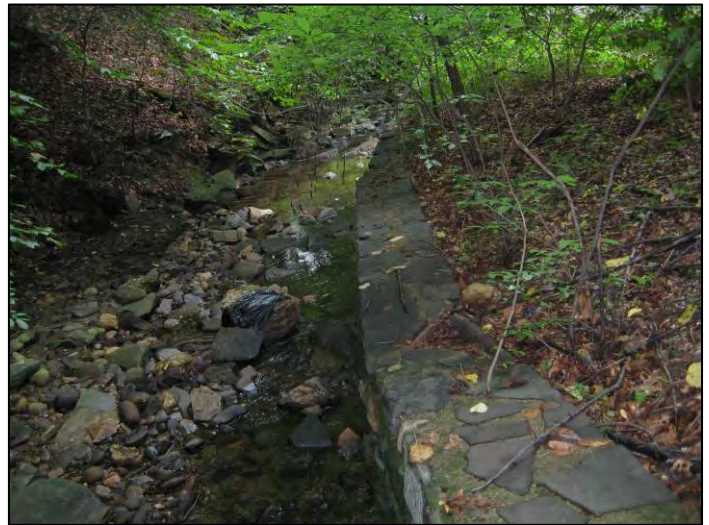
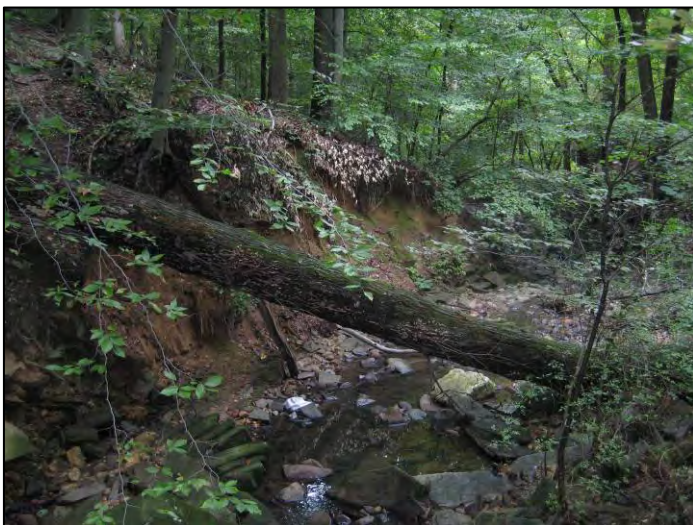
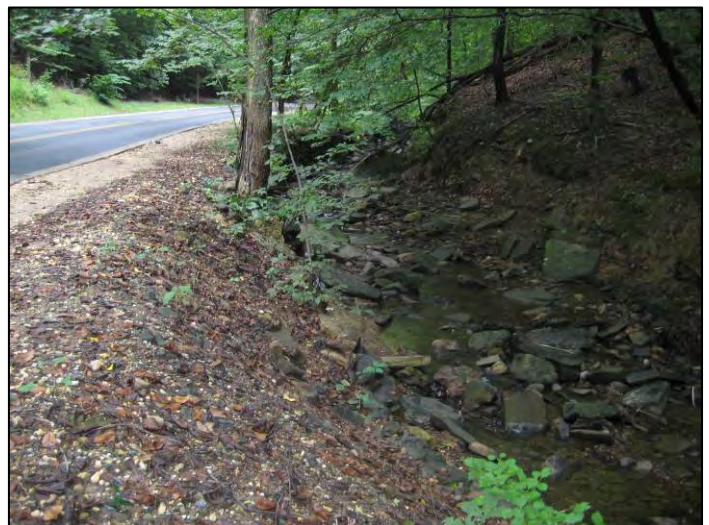
PROJECT_NUMBER	RC_Stream_30
SITE_LOCATION	Blagden Run - Mathewson Drive NW and Blagden Avenue NW to Rock Creek
ADC_MAP_LOCATION	5408_C10
OWNERSHIP	Public
APPROXIMATE_LENGTH (Feet)	974
DESCRIPTION_OF_EXISTING_CONDITIONS	Stream emerges from outfall south of Mathewson Drive and follows Blagden Avenue to Rock Creek. Bank closest to Blagden Ave is hardened, other bank soft. Stream incised in locations. Barrier to fish passage at mouth of Blagden Run.
PROJECT_DESCRIPTION	Mixture of hard and soft stabilization practices. Remove barrier to fish passage at mouth of stream.
ESTIMATED_COST	\$730,455.00
PROJECT_RANKING_EDUCATION	High
PROJECT_RANKING_ENVIRONMENT	Medium
PROJECT_RANKING_INSTALLATION	High

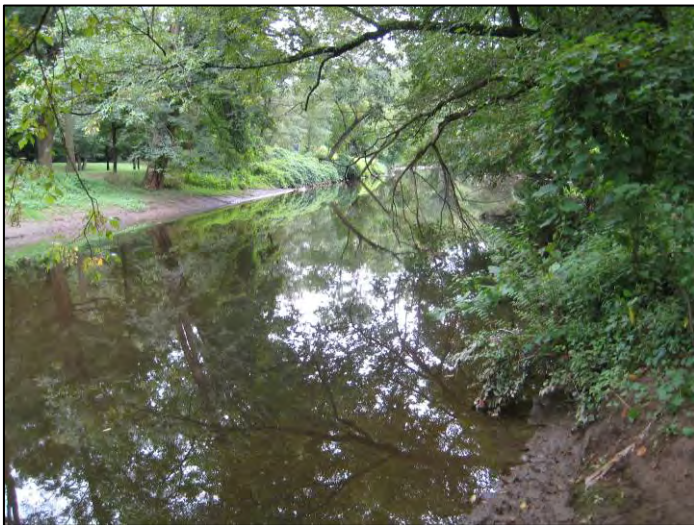
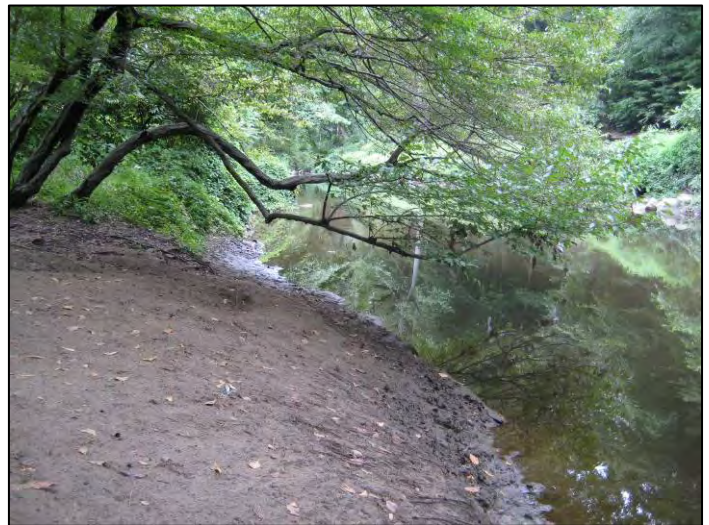
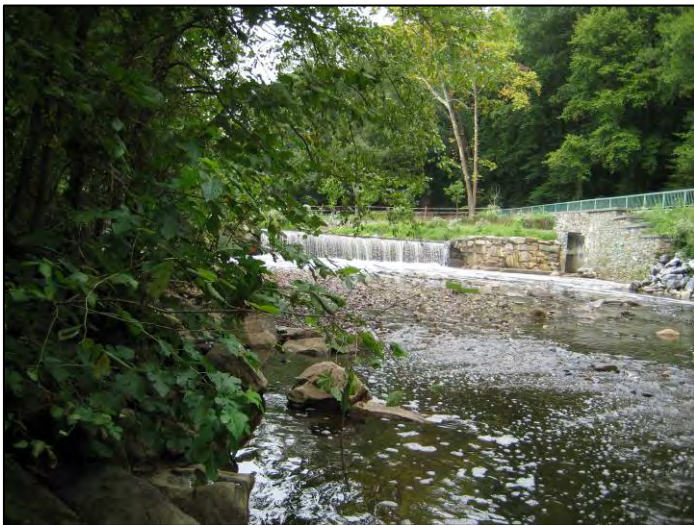
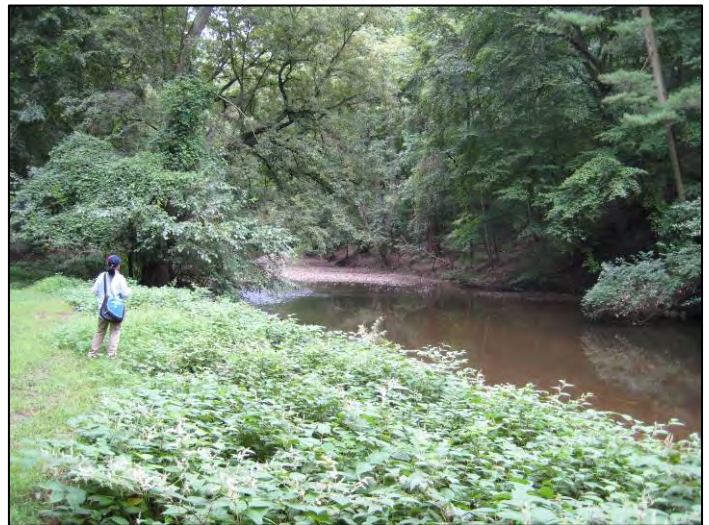
RC_Stream_31

Forested stream valley with 2-lane road adjacent to stream for length of stream segment. Stream has mix of hardened bank structures and soft banks. Soft banks sometimes show downcutting. Storm and sewer infrastructure present in stream valley.

Predominantly installation of soft structures and planting of stream banks with deep rooted vegetation. Some bank hardening and flow diversion devices to protect infrastructure.

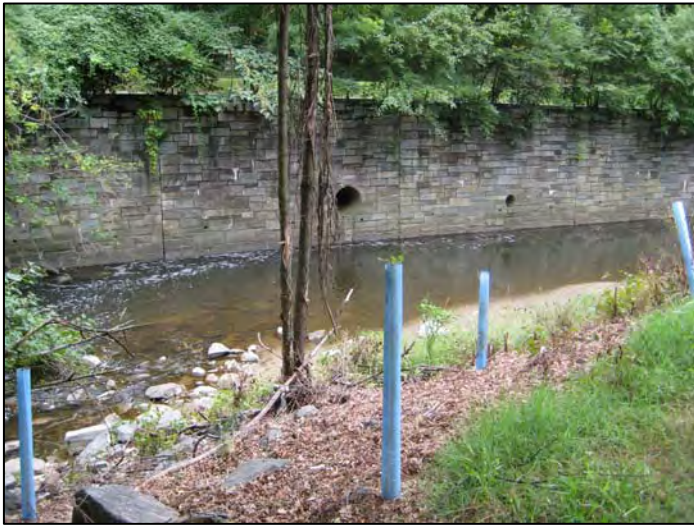
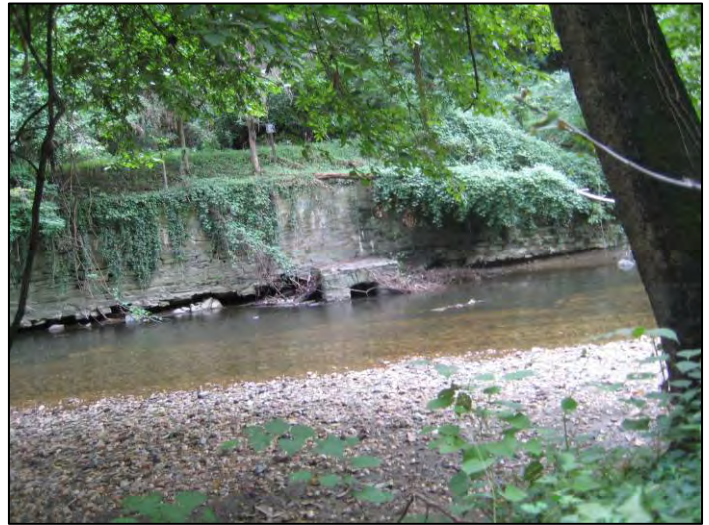
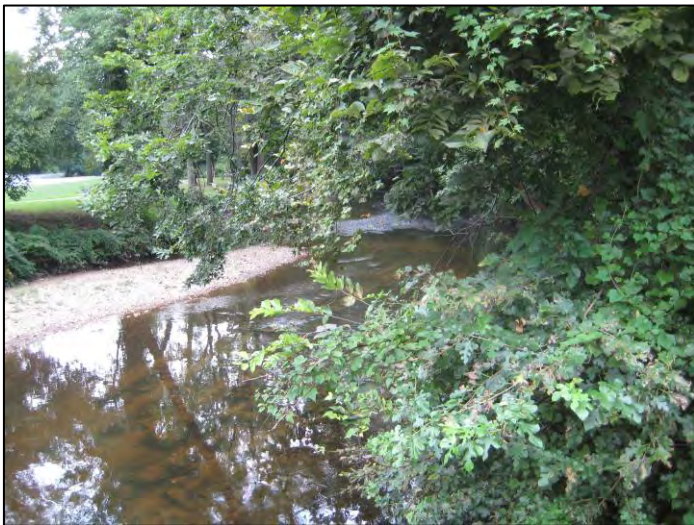
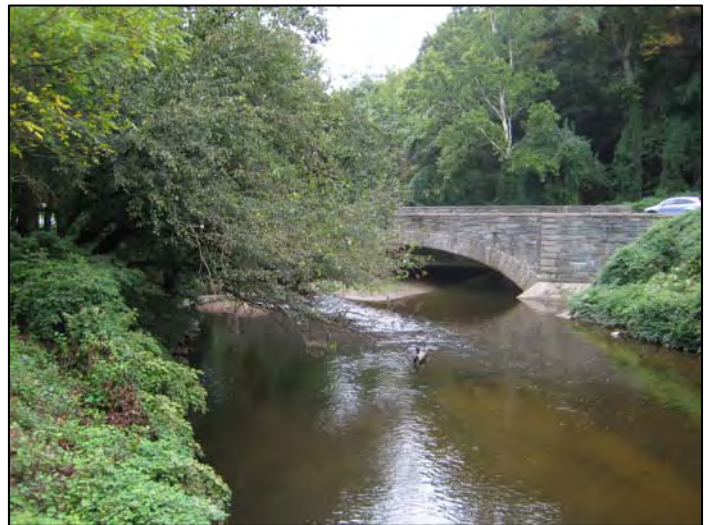
RC_Stream_32

Forested stream valley with 2-lane road that becomes 4 lane parkway adjacent to stream for length of stream segment. Stream predominantly hardened bank structures on road side. Storm and sewer infrastructure present in stream valley.

Predominantly installation of soft structures and planting of stream banks with deep rooted vegetation opposite road side. Restoration of bank hardening and flow diversion devices to protect infrastructure. Plant willow stakes in hardened structures.

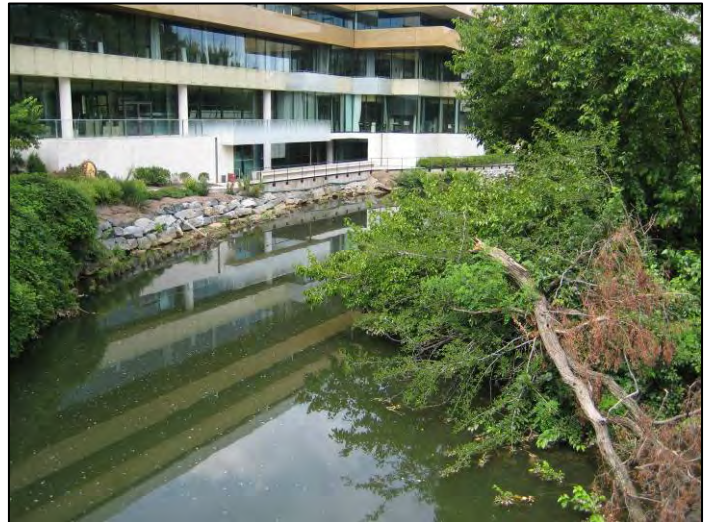
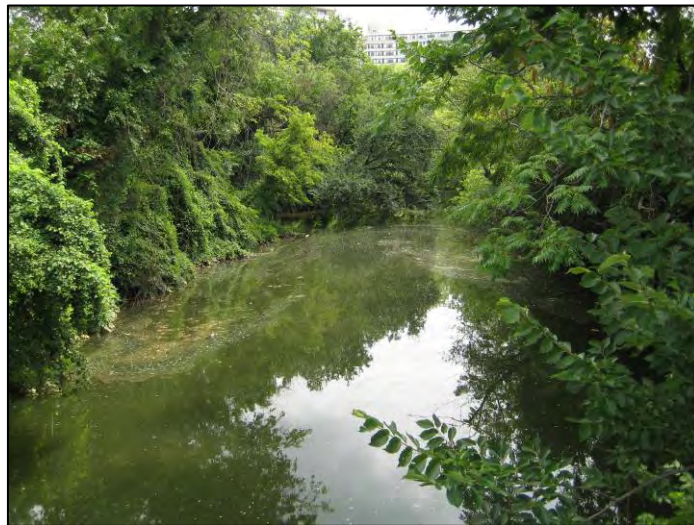
PROJECT_NUMBER	RC_Stream_35
SITE_LOCATION	Rock Creek main stem - Pennsylvania Avenue NW to the Potomac River
ADC_MAP_LOCATION	5528_A6
OWNERSHIP	Public
APPROXIMATE_LENGTH (Feet)	2198
DESCRIPTION_OF_EXISTING_CONDITIONS	Stream valley predominantly grass with 4 lane parkway adjacent to stream for length of stream segment. Stream predominantly hardened bank structures on both sides. Storm and sewer infrastructure present in stream valley.
PROJECT_DESCRIPTION	Predominantly restoration of hardened banks and flow diversion devices to protect infrastructure. Plant willow stakes in hardened structures and reforest grass areas.
ESTIMATED_COST	\$1,648,560.00
PROJECT_RANKING_EDUCATION	High
PROJECT_RANKING_ENVIRONMENT	High
PROJECT_RANKING_INSTALLATION	High
