RiverSmart Washington Post-Implementation Monitoring Phase 2

September 2020 Final Report

Prepared for:
Department of Energy and
Environment

September 29, 2020

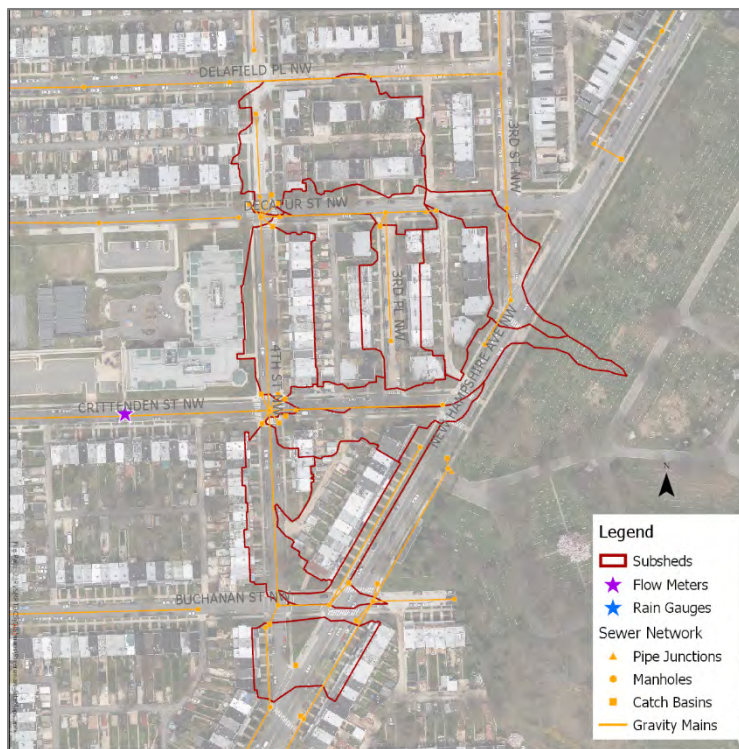
Figure 2-1. Control Site Map

The Control site (sewershed code CSO-049G) is within the combined sewer portion of the city, specifically the large Piney Branch sewershed in the Rock Creek watershed. It is roughly bounded by New Hampshire Avenue, 3rd Street, 4th Street, and Delafield Place. Its land use is primarily residential. This site is 10.4 acres and is 60% impervious. Its location, as well as its sewer network and the location of its flow meter, are depicted on Figure 2-1.

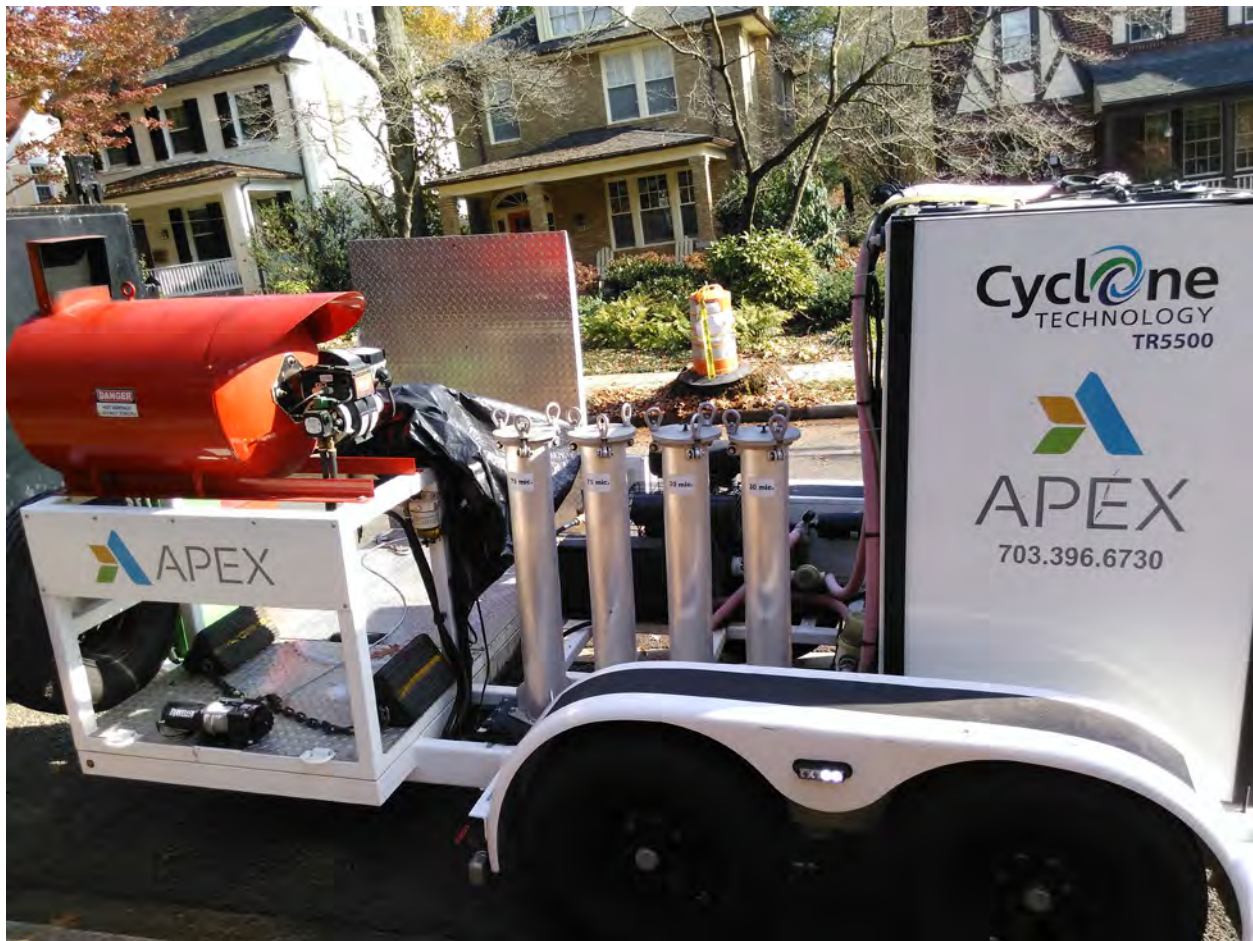
Figure 4-1. Apex Cyclone TR5500

The restorative cleaning of the RiverSmart permeable surface LID practices was conducted using special equipment that was designed specifically to clean LID surfaces. The equipment used to clean permeable concrete and asphalt surfaces, operating under the brand name Cyclone Technology, features a trailer-mounted water tank, water recycling unit with filtration, and pressure pump that can produce a maximum of 3,600 psi (Cyclone TR5500), paired with a pressure washer unit (Cyclone CY210). The pavers were cleaned with a hydrovac truck coupled with a PaveDrain cleaning head. Figures 4-1 through 4-3 are photos from November 2019 cleaning of LID practices at the Lafayette site.

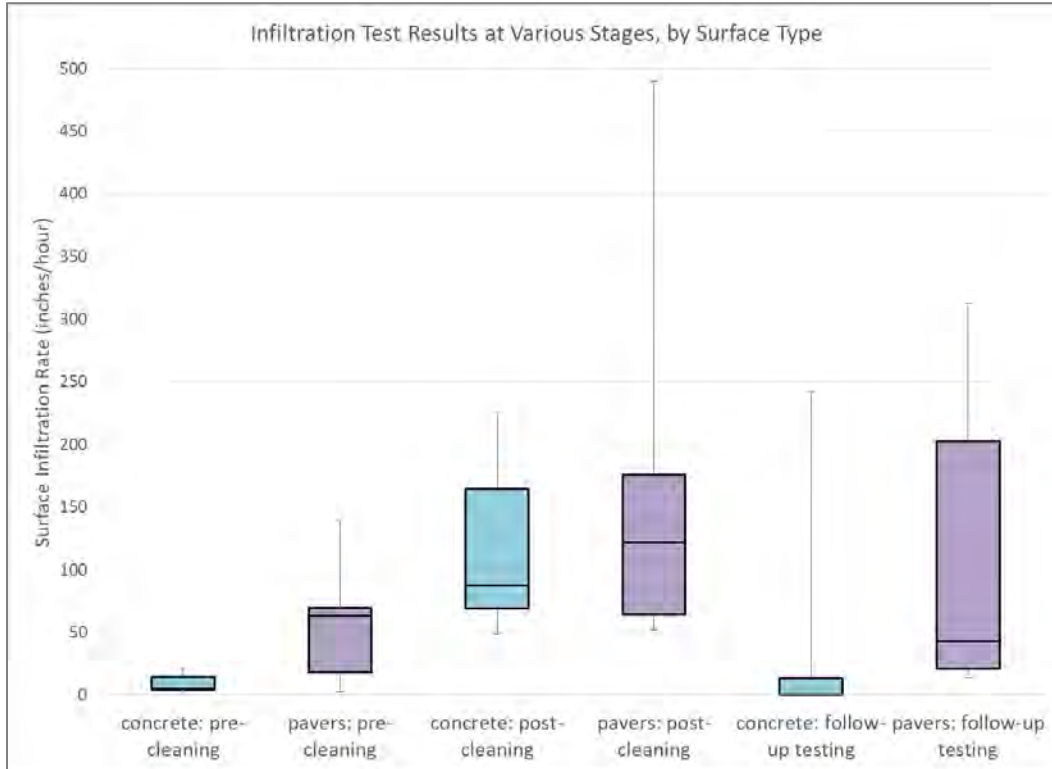
Figure 4-4. Infiltration Rates, by Surface Type

only two practices, both of those practices had failing infiltration rates in pre-cleaning testing, and failing rates in follow-up testing. Concrete LID practices showed the most variability, with some responding well to cleaning and maintaining good follow-up rates, but with others having failing rates in follow-up testing. The differences between the two sites may be explained by the previously-mentioned greater tree canopy and pervious yard runoff in Lafayette than in MacFarland.

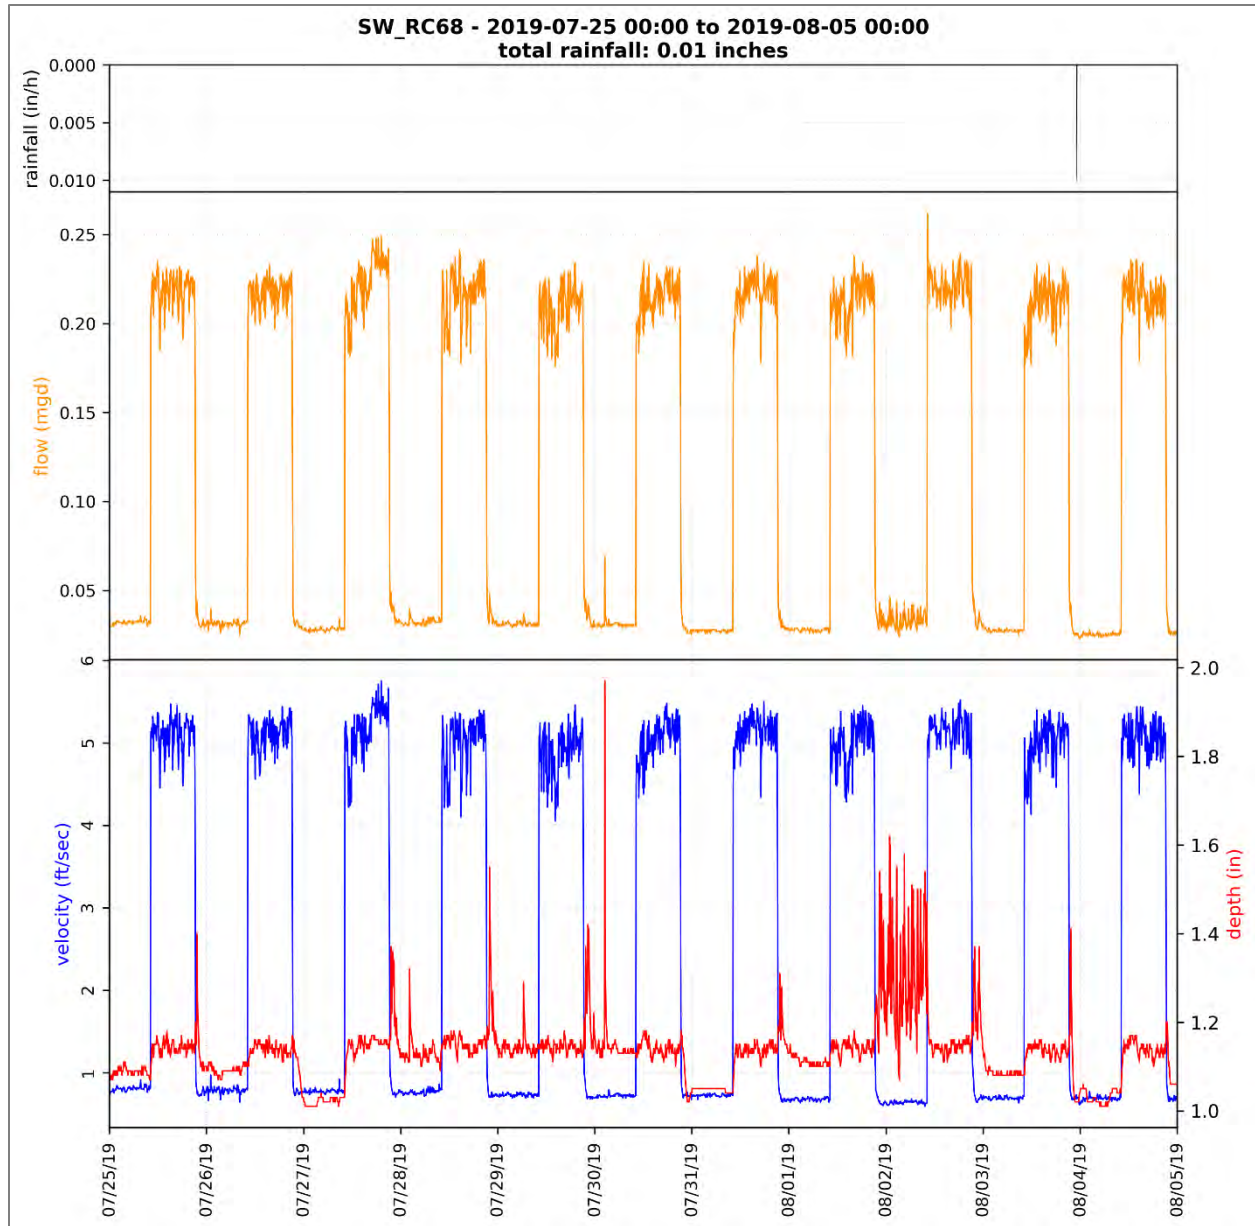
Figure 5-1. Lafayette Summer 2019 Dry Weather Diurnal Pattern

Problems with data quality in Lafayette for June-August 2019 which showed an unexpected diurnal flow pattern that introduced significant noise to the flow signal, further reduced the pre-rehabilitation analysis period, to a total of only three events in September and October 2019. Figure 5-1 is a plot of the large-magnitude Lafayette dry weather flow pattern that was observed from June through August 2019.

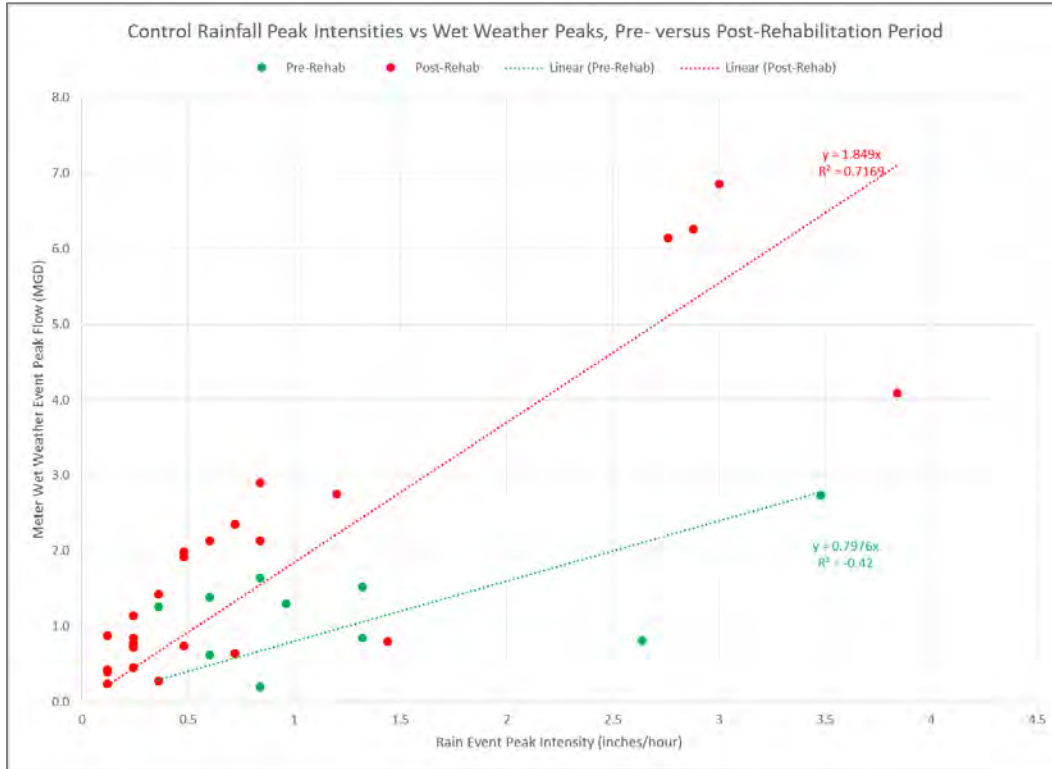
Figure 5-5. Control Site: Rainfall Peak Intensities versus Peak Flows

Figures 5.5 through 5.7 are one-to-one plots that compare the event peak flow responses with peak rainfall intensities. Comparing the Control and MacFarland plots, the Control plot peak flows increase for the post-rehabilitation period, while peak flows decrease in MacFarland for that same period. This may indicate that while wet weather volume analysis of sewer meter data indicates that LID practices are not *retaining* (infiltrating) flows, they are decreasing peak flows by temporarily *detaining* (holding) flows.

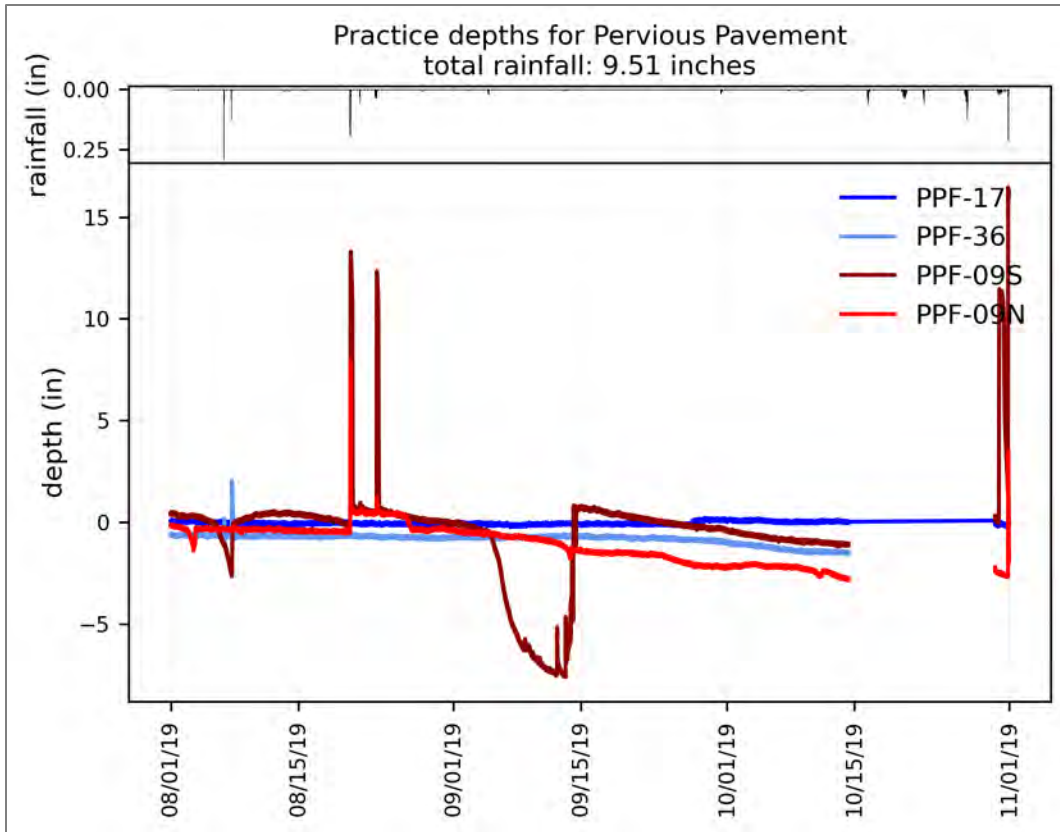
Figure 5-12. Observed Pre-Cleaning Practice Water Levels

- PPF-9 water levels respond to the group of August 2019 events, with relatively rapid increase and drawdown of water levels;
- The installed water level sensors are not immune to calibration issues, as can be seen with the negative values in September and October;
- Consistent with pre-cleaning infiltration testing, the Lafayette practices (PPF-17 and PPF-36) show very little response to rain events.

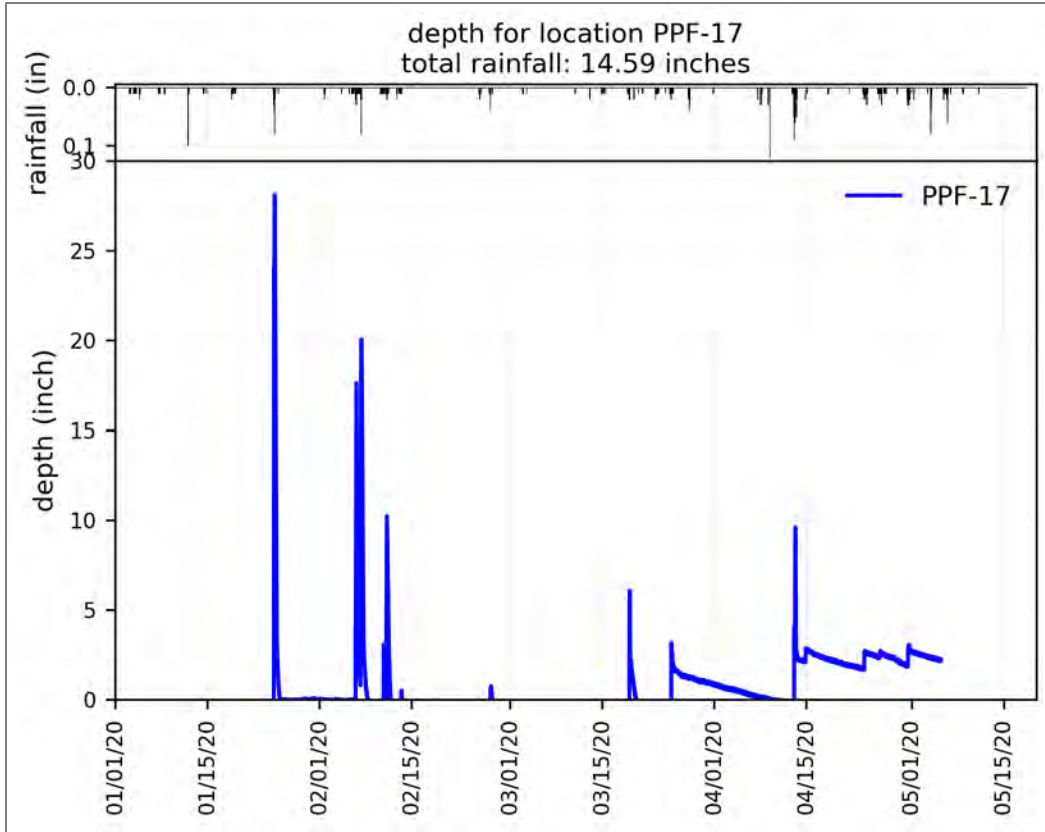
Figure 5-13. PPF-17 Observed Water Levels, Post-Cleaning

Figure 5-13 is a plot of PPF-17 water levels post-cleaning. Consistent with the follow-up infiltration test results that indicate failure 3-4 months after cleaning, there is a decrease in maximum water levels over time. There is also some inconsistency in observed drawdown times for this practice; there is rapid decrease in water levels in January and February, but slower recession for events from March-May.

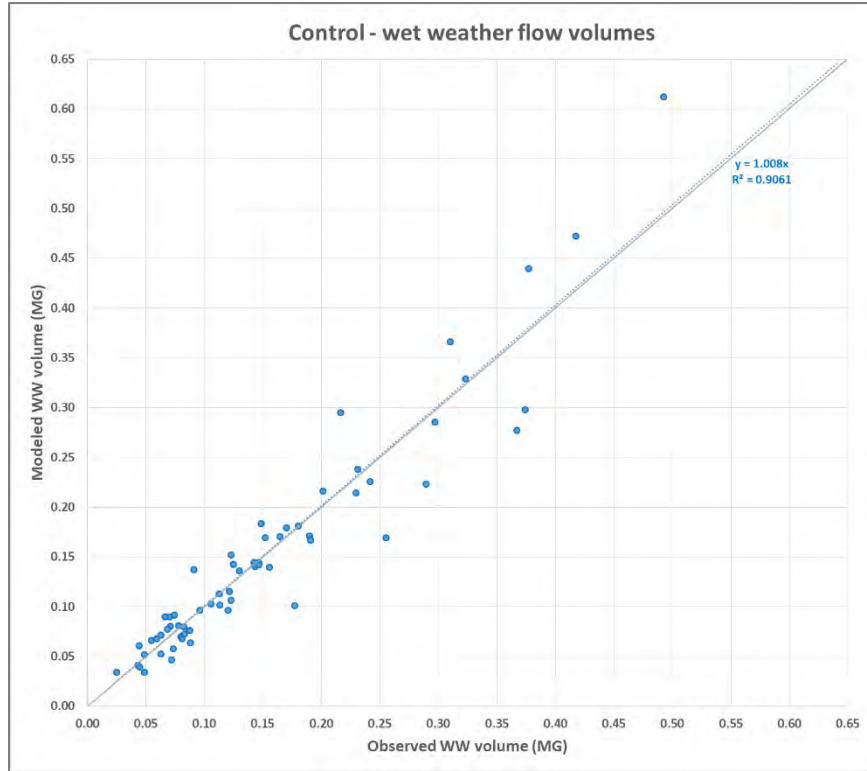
Figure 6-1. Model-Data Match for Wet Weather Flow Volumes at the Control Site

As described previously, a change in the model calibration methodology was necessary due to the observed trend in increased wet weather responses across all sites. The baseline model for the Control site was re-calibrated to the 2019-2020 flow metering data after an initial model run with the existing parameterization showed the model under-predicting flow volumes as well as flow peaks. Runoff parameters for percent impervious, flow path length, slope and Horton soil infiltration rates were adjusted to match the observations. One-to-one plots for wet weather event volumes are shown in Figure 6-1 and plots for wet weather peak flows are shown in Figure 6-2. The statistical model-data match is satisfactory, with the model over-predicting volume with less than 1% on average and an R-squared value of 0.91 for the wet weather volumes, and an over-prediction of less than 10% for wet weather peak flows with an R-squared value of 0.83. A total of 64 wet weather events were used for the model calibration at the Control Site.

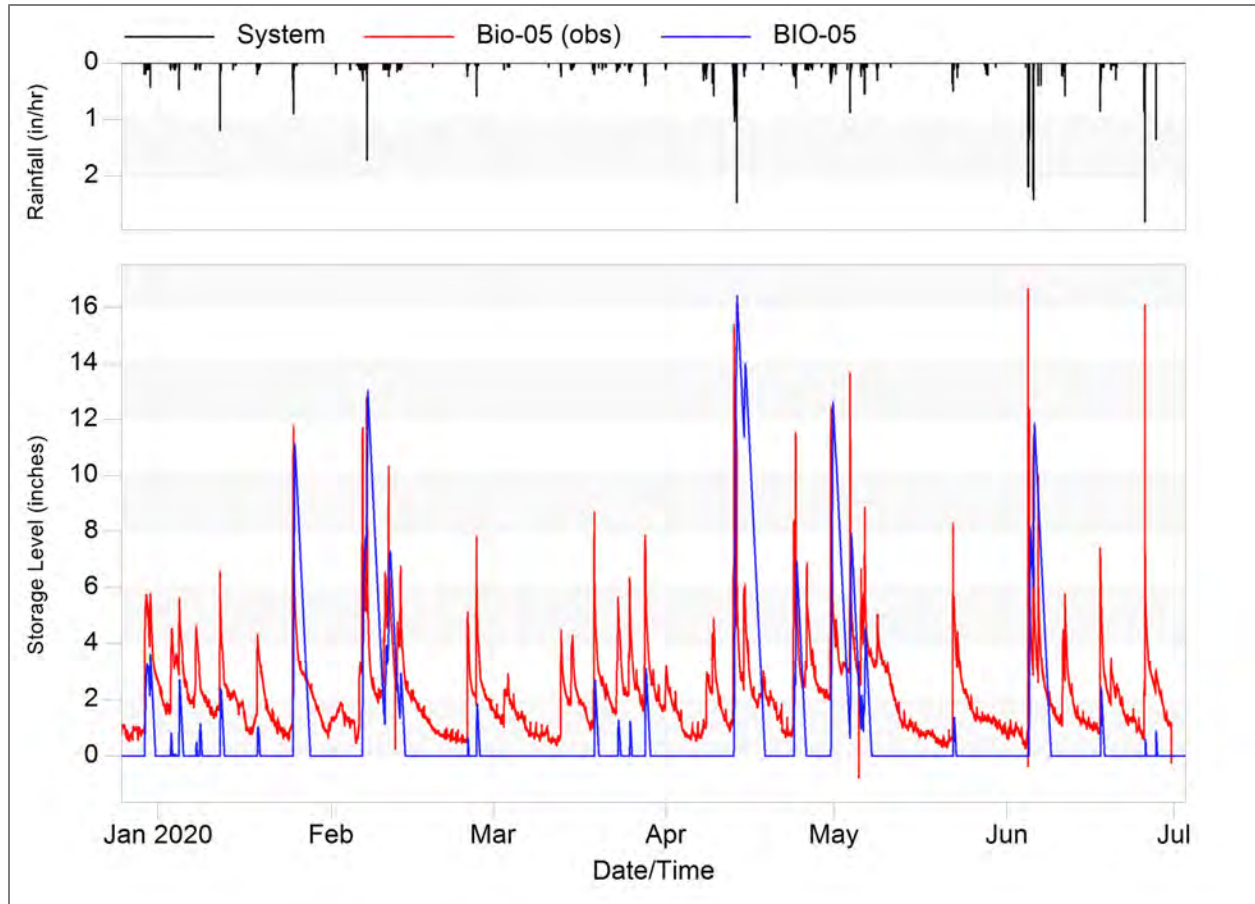
Figure 6-7. BIO-05 Practice Calibration Result

() The storage porosity and CDA size are directly linked. Storage porosity has been assumed to be at 75% of the design value to account for potential compaction and sedimentation of the storage layer.*

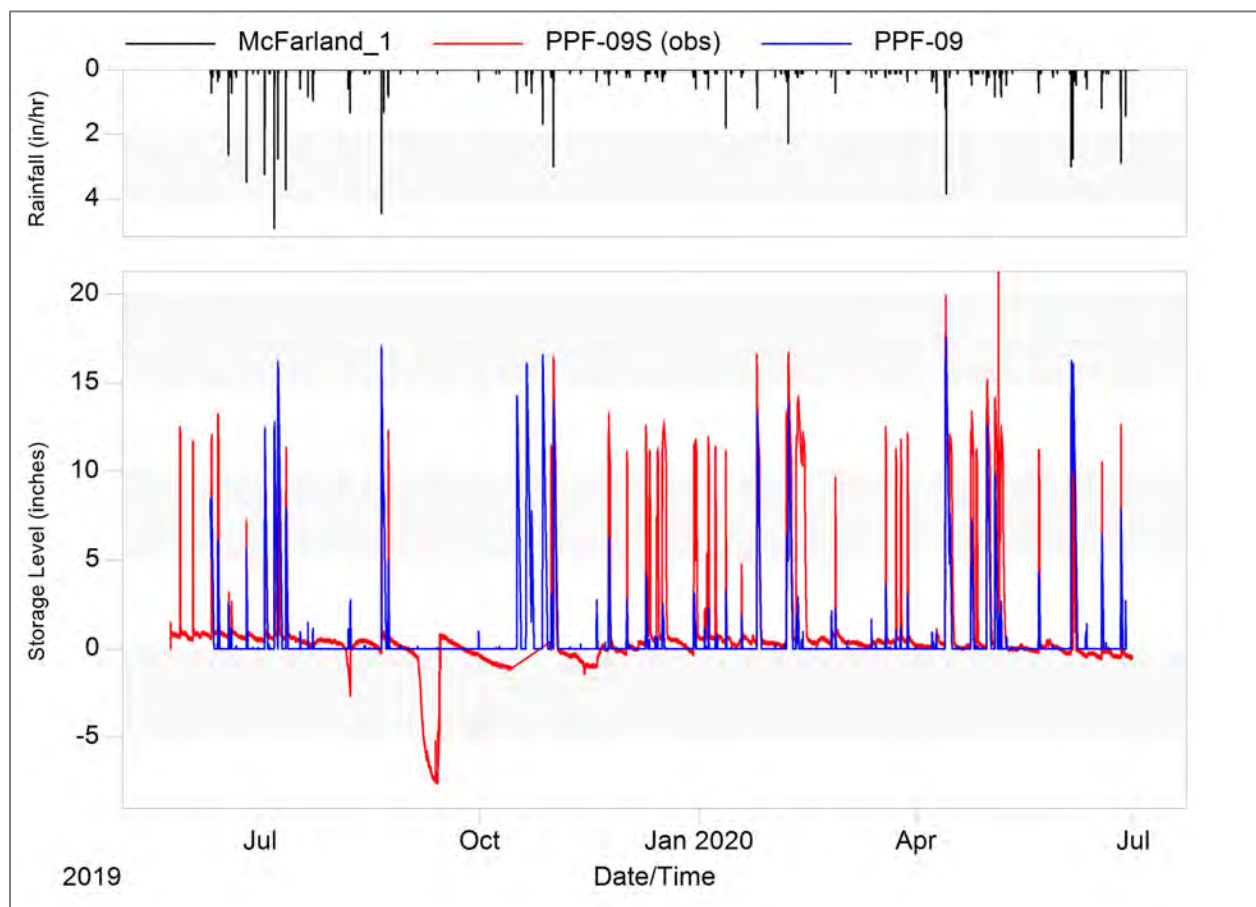
Figure 6-11. PPF-09S Practice Calibration Result

Monitor PPF-09S on the southern end of the practice indicated better performance than PPF-09N, but further improvements due to the practice cleaning are not evident in the data. The practice was re-calibrated in the SWMM model for the entire monitoring timeframe of June 2019 to July 2020. The re-calibrated SWMM parameters are listed in Table 6-8. Figure 6-11 shows a comparison between observed

() The storage layer capacity had to be lowered to 10% in order to reach the observed water levels in the model given the available potential drainage area.*

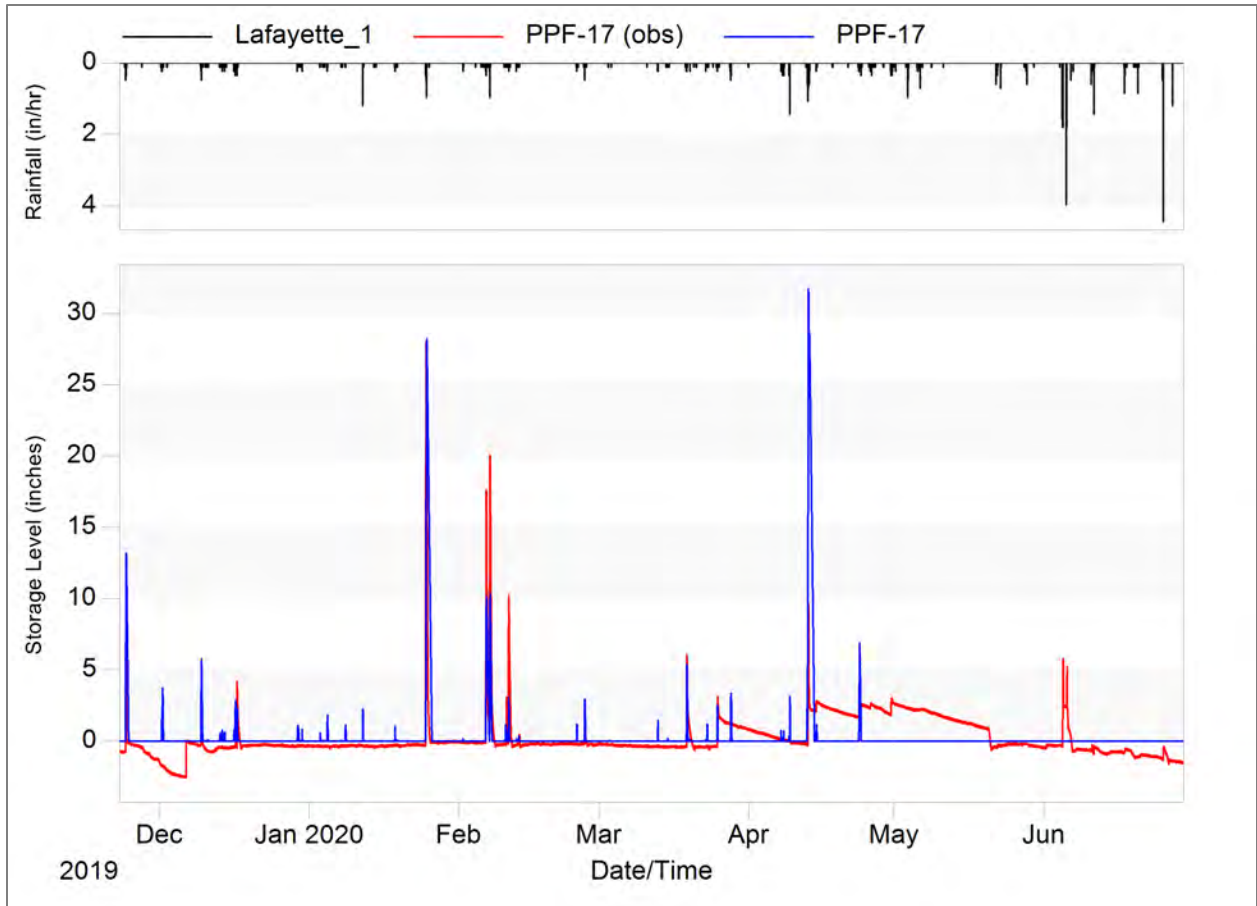
Figure 6-12. PPF-17 Practice Calibration Result

*(**) Starting infiltration rate was calibrated to 100 in/h which matches the observed infiltration rates directly after the practice was cleaned. This rate drops to zero in the model over a six month timeframe.*
