Branch Ave Park Stream Restoration
Erie Street SE & Branch Avenue SE
Final Design Report

August 6, 2019

Department of Energy and Environment, District of Columbia Government, Watershed Protection Division
1200 First Street, N.E., 6th Floor
Washington, DC 20002

**STRAUGHAN
ENVIRONMENTAL**

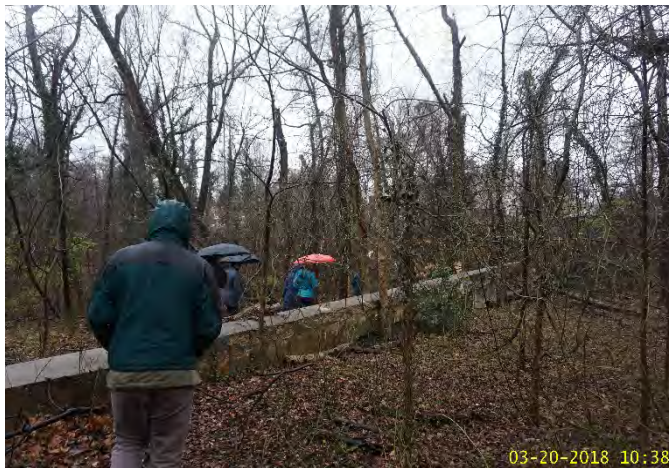
Photo 1 – Above ground sewer line running in a concrete encasement from Branch Avenue to Erie Street.

Several existing site characteristics constrain a potential restoration design. The largest constraint is the existing above ground sewer line between Branch Avenue and Erie Street north of

the storm drain inflow. Per DOEE instruction, the proposed design must avoid disturbing the concrete structure and its foundations. The design will also need to consider impacts to the forested character of the site. Currently the stream is surrounded by several large 24 to 40-inch diameter trees that are not only of an important ecological value but also a community asset providing screening from the busy intersection. DOEE has noted that both they and the community value forested cover.

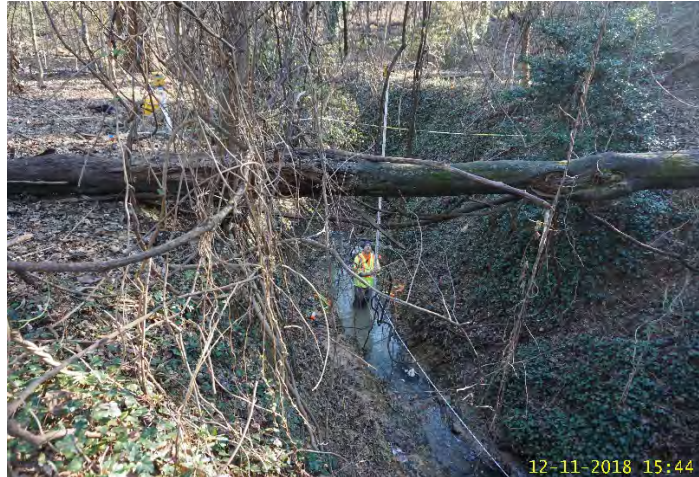
Photo 3 –Cross Section 1.

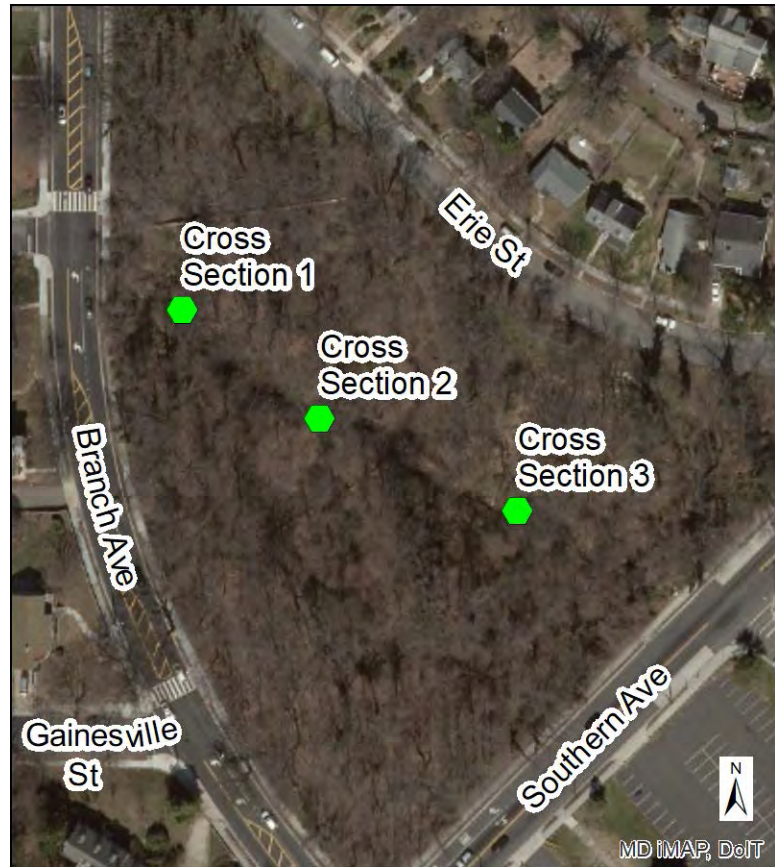
Figure 1 – Location of the geomorphic cross sections, where bank pins and BEHI assessments were performed

The field team observed a floodplain bench that is a potential bankfull indicator at the downstream cross section 3. The remaining sections of stream did not display any identifiable bankfull indicators due to extreme entrenchment and instability.

Based on the selected bankfull discharge of 32 cfs from cross section 3, the stream is a Rosgen Type G in the upstream reach at cross section 2 where the stream is fully entrenched not accessing the floodplain. The downstream reach is transitioning to a Rosgen Type B stream where bank and erosion and overbank deposition are beginning to develop a new floodplain.

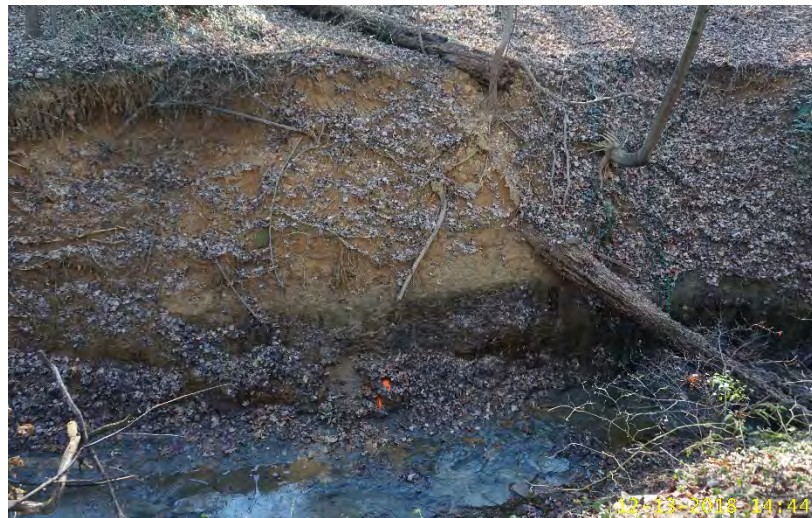
Photo 4 – Bank pins on the right bank at Cross Section 2. Driven into the clay bank.

Straughan installed three sets of four rebar bank pins on December 11, 2018. The bank pins are installed at the locations of the Bank Erosion Hazard Index (BEHI) assessments and the

During subsequent field visits, we noted that the site is experiencing types erosion that will not be well captured by the bank pins alone. On a March 27, 2018 field visit, Straughan identified a recent “mass wasting” bank failure near cross section 2, in which the full bank slope failed near its top and sloughed into the stream (over the bank pins). Straughan recommends that the bank pin data be supplemented with field-informed assumptions on any slope failures that may interfere with the estimates. Straughan will return to periodically check the pins over the next year until construction starts.

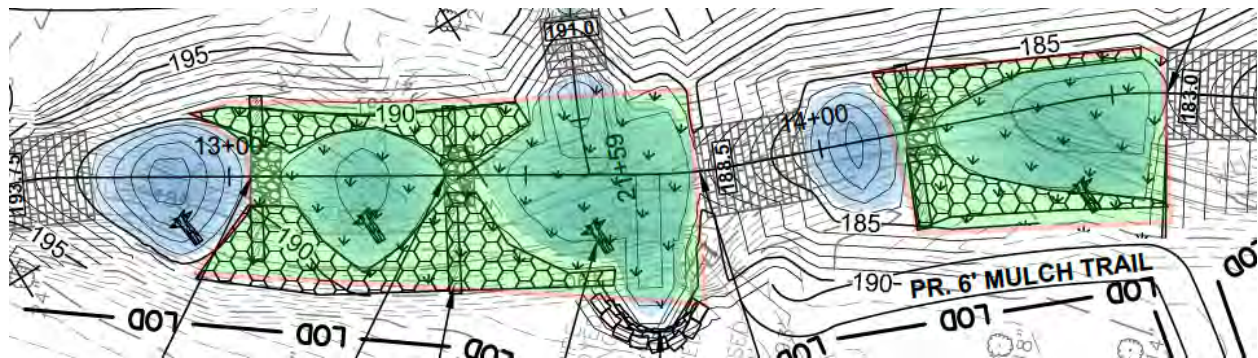
Figure 7: Qualifying floodplain connection area

The potential floodplain connection area is shown in Figure 7. This area totals approximately 3,820 square feet.

The total drainage area for the project is 45.9 acres, or 1,999,404 square feet. Therefore, the available floodplain area compared to watershed area has a ratio of 0.2%. Any credit for floodplain reconnection volume would be reduced to an efficiency of 20%.
