**DEPARTMENT OF ENERGY & ENVIRONMENT**  
**Palisades Recreation Center**

Final Report, September 2020  
DPR II – Design and Build 4 LID Sites  
Contract Number CW712222

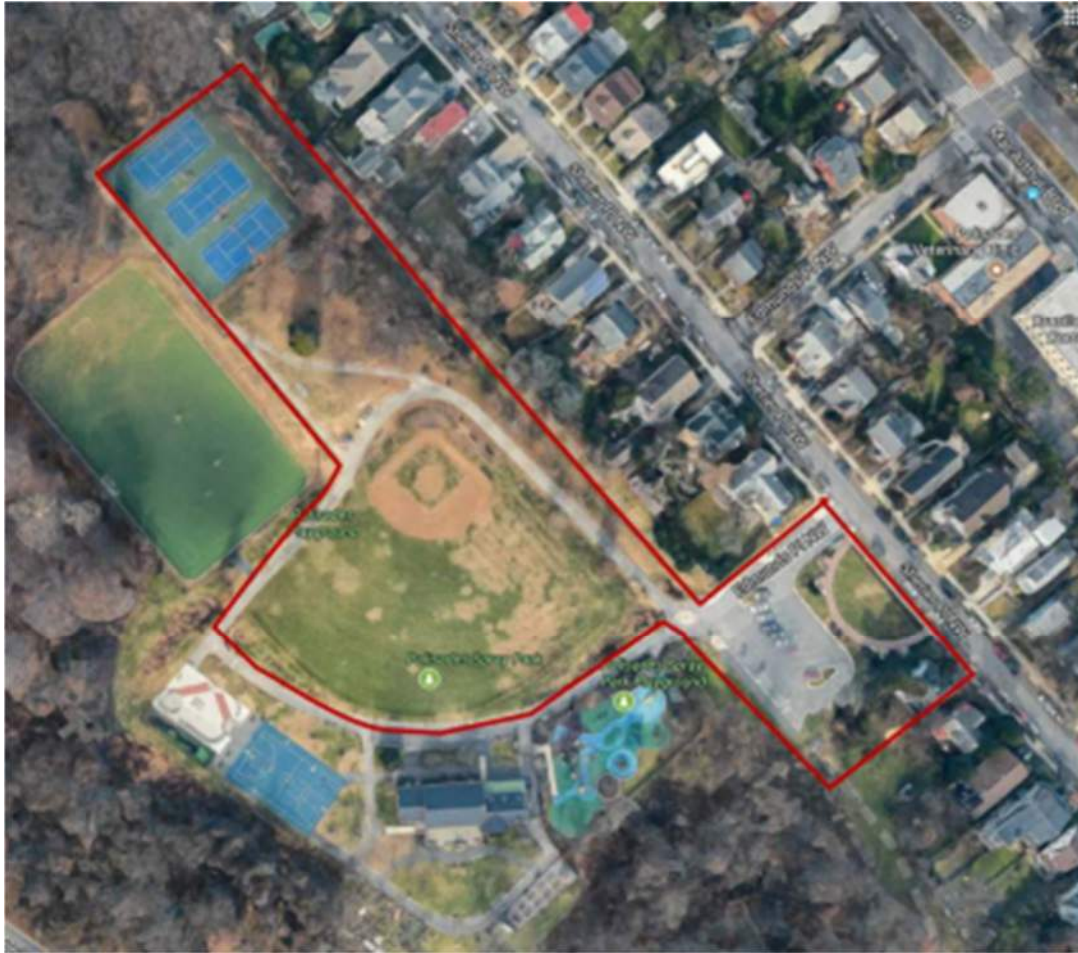
*Figure 2 – Project Site (outlined in red) as provided in the DPR II RFP*

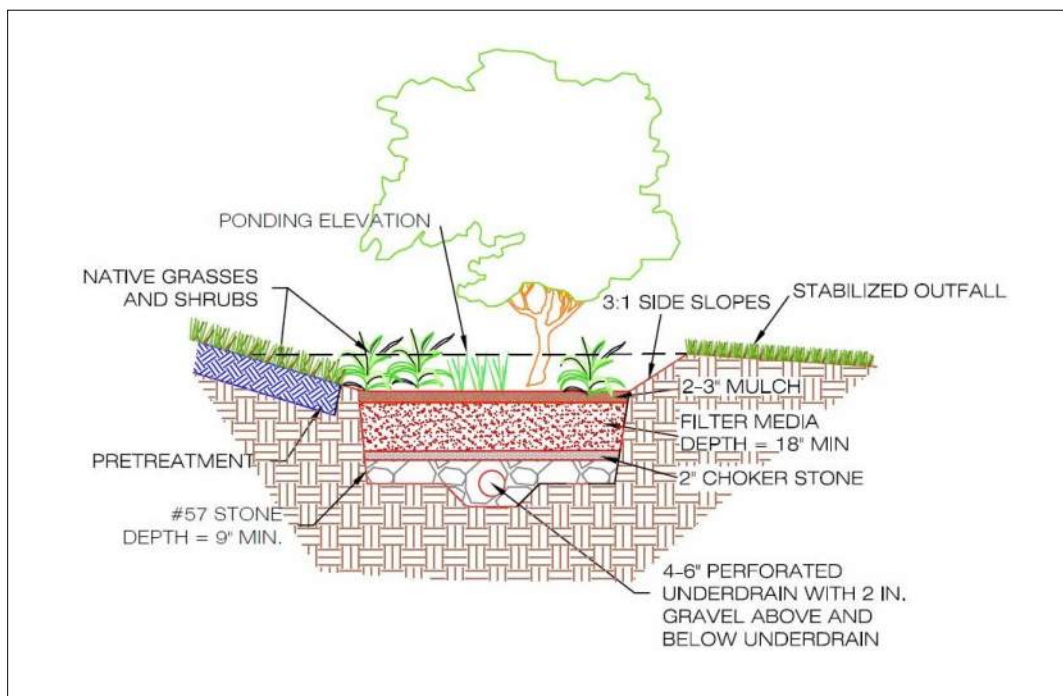
***Example of standard bioretention design.***

**Definition.** Practices that capture and store stormwater runoff and pass it through a filter bed of engineered filter media composed of sand, soil, and organic matter. Filtered runoff may be collected and returned to the conveyance system or allowed to infiltrate into the soil.

*Bioretention systems are typically not designed to provide stormwater detention of larger storms (e.g., 2-year, 15-year), but they may be in some circumstances. Bioretention practices shall generally be combined with a separate facility to provide those controls.*

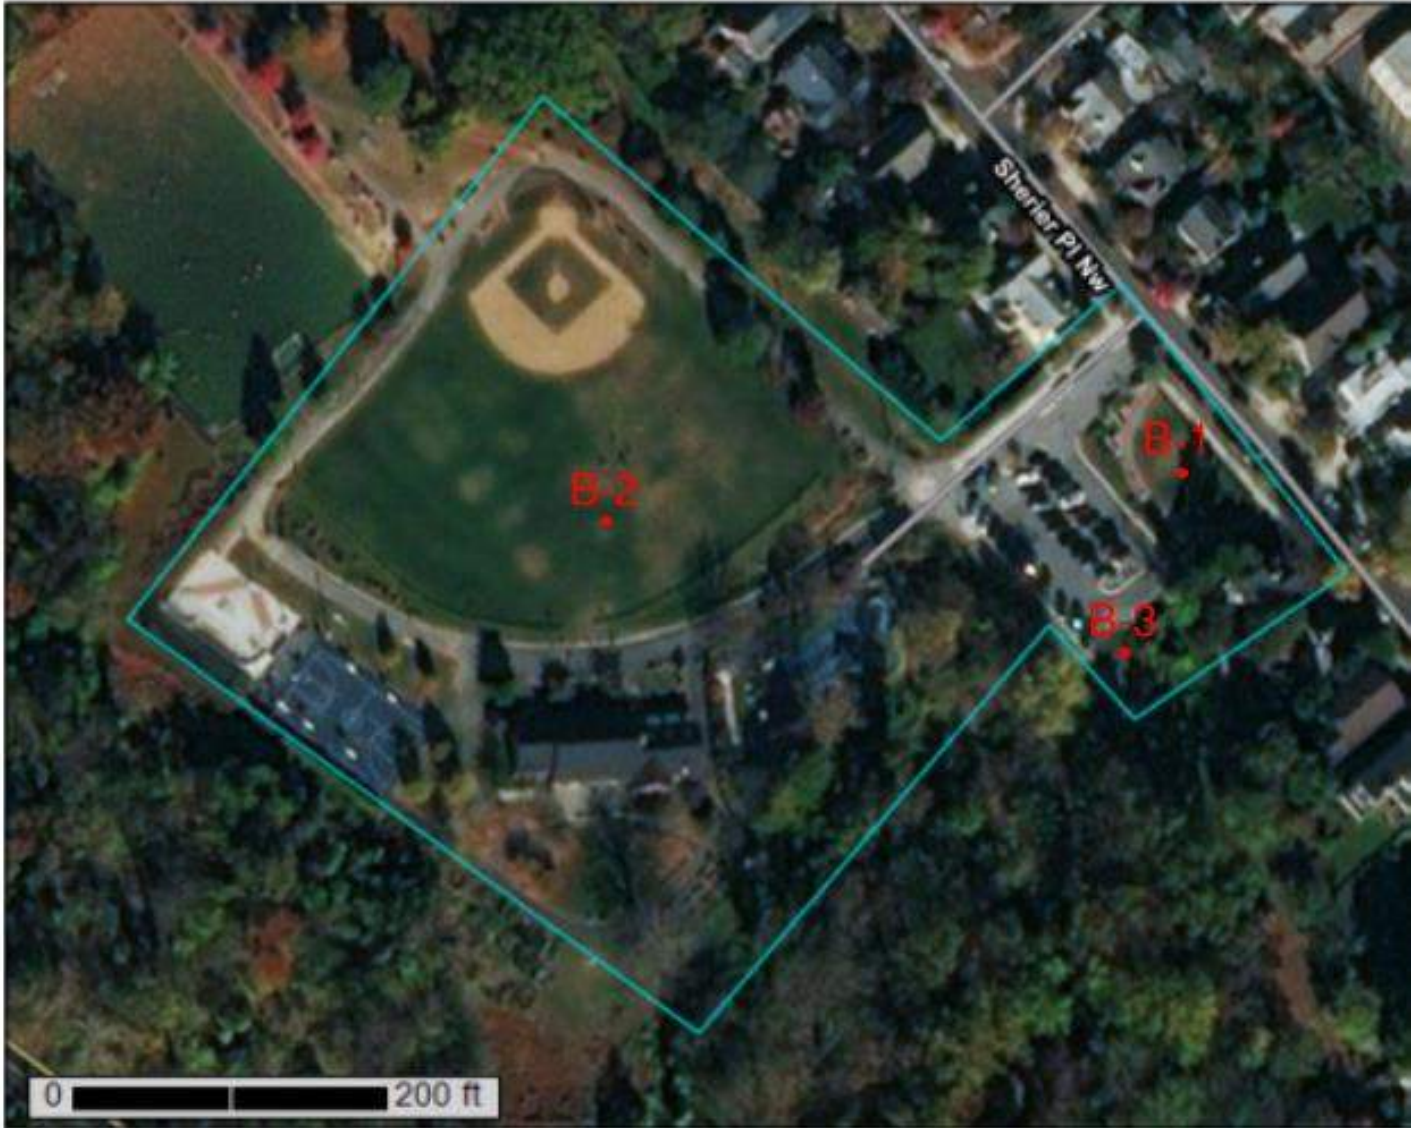
**Figure 2 – Soil Boring Locations**

Boring B-1, located in semi-circular turf area between Sherier Place NW and the parking lot, was advanced through the soil overburden to a depth of 32 inches below the existing site grade. Large gravel was encountered at 4 inches deep. This transitioned to large (8 inches) riprap at 32 inches, at which point the boring was terminated. Voids and unconsolidated soils were observed between the riprap, indicating this area was filled. Discussions with local resident indicated this is the past site of a single family residence which was razed when the park was first developed. No indications of seasonally high groundwater were observed.

parking area. This boring was advanced to a depth of 22 inches prior to termination due to cobbles. Construction debris was noted in this boring. Further investigation indicated that the entire area would be part of the backfill for the 78-inch diameter water line that runs under this area. This boring was abandoned and backfilled without further investigation.

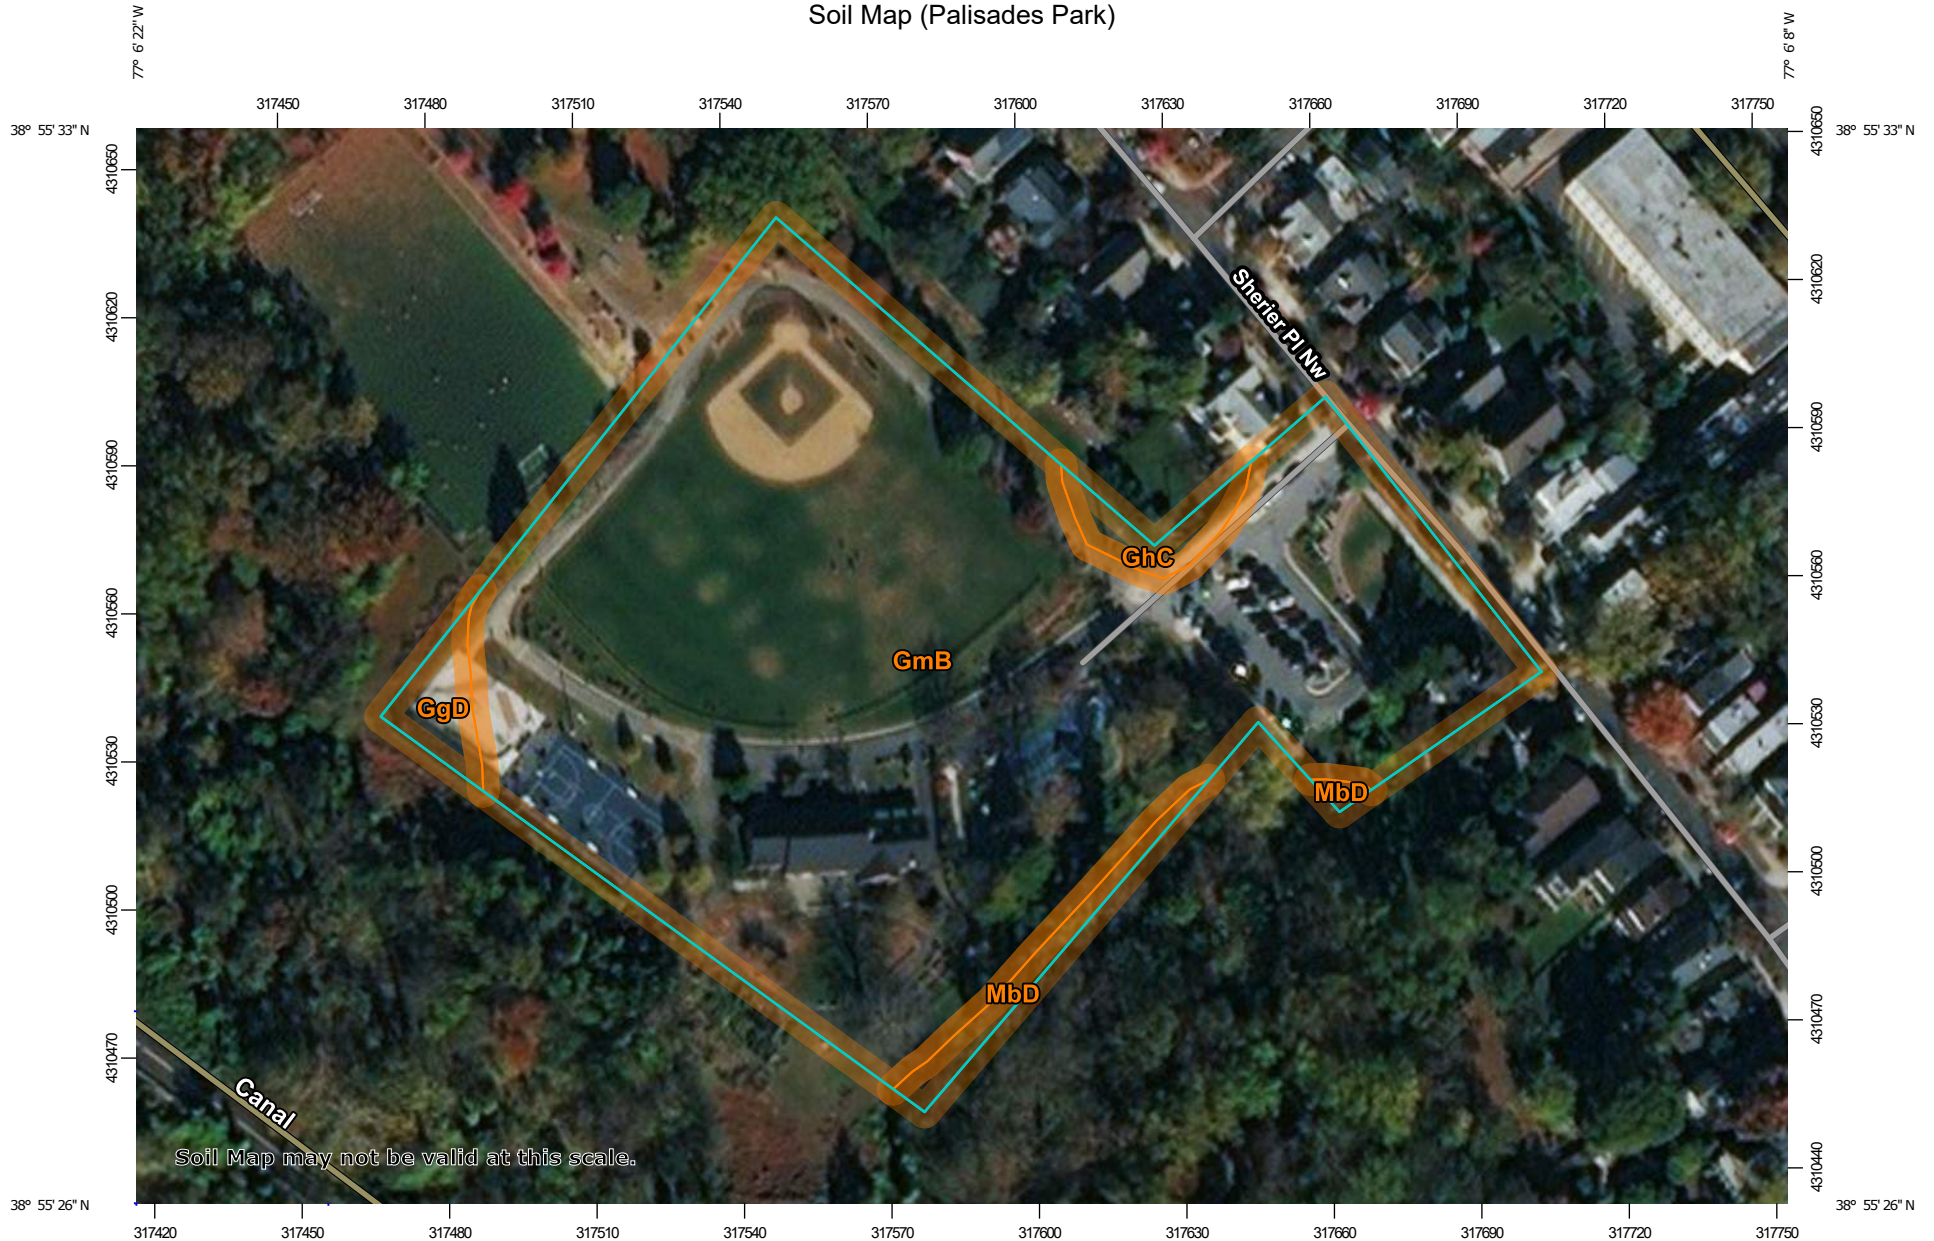
# Custom Soil Resource Report Soil Map (Palisades Park)

The soil map section includes the soil map for the defined area of interest, a list of soil map units on the map and extent of each map unit, and cartographic symbols displayed on the map. Also presented are various metadata about data used to produce the map, and a description of each soil map unit.

Soil Map may not be valid at this scale.

Map Scale: 1:1,540 if printed on A landscape (11" x 8.5") sheet.

Based upon the USDA Websoil Survey (included as part of the geotechnical evaluation report in Appendix B), soils across the site consist of an urban land variant of the Glenelg series soil. Where undisturbed, the original base soil is a well-drained loam with good infiltration characteristics.
