Douglass Community Center

Design Report, November 2020

DPR II – Design and Build 4 LID Sites

Natural Resources Design, Inc

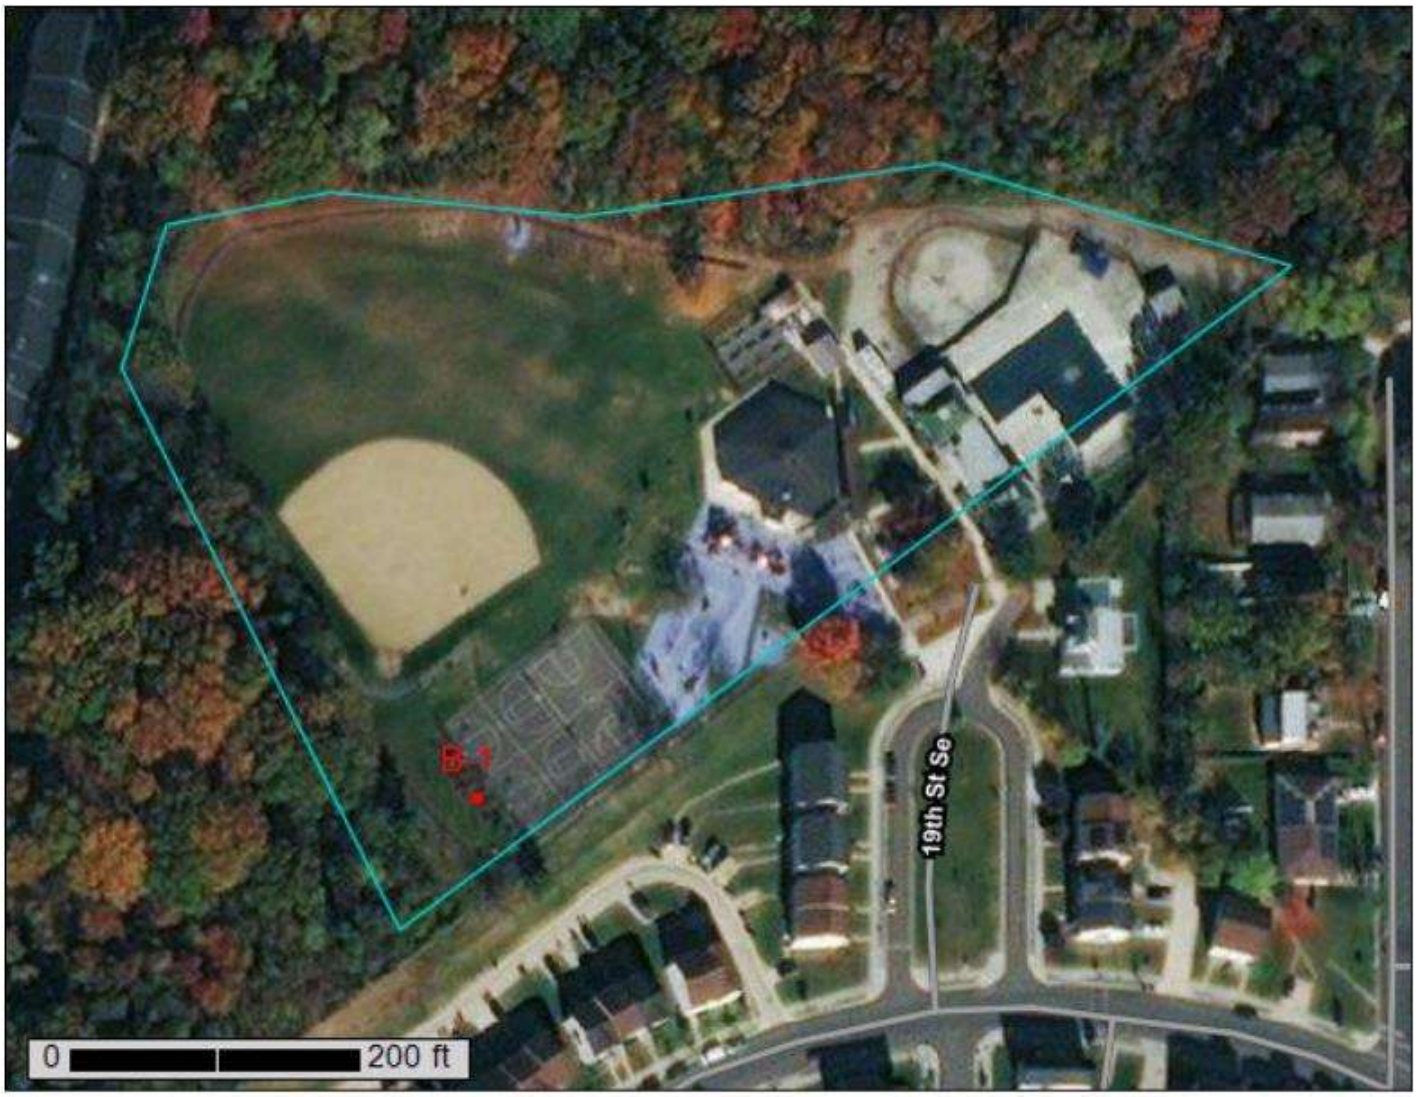
Figure 2 – Soil Boring Location

A soil boring and infiltration test was performed within the bioretention basin. This evaluation indicated the basin construction consists of approximately 22 inches of bioretention mix over a 12-inch deep gravel drainage layer. There is a layer of nonwoven geotechnical fabric separating these layers. Based on the survey, the ponding depth within this basin is approximately 12 inches.

Boring B-1, located in the approximate center of an existing bioretention basin adjacent to the basketball courts, was advanced through the existing bioretention media, geotextile fabric, drainage gravel and subsoil. Boring was terminated at a depth of 50 inches below the surface elevation.

Based upon the high infiltration rates in the bioretention basin subsoils, this area is well suited for location of an infiltration-based BMP without requiring installation of an underdrain system. In order to ensure proper function, the existing system should be excavated and reconstructed to current standards.
