Appendix B: Stream Restoration Sites

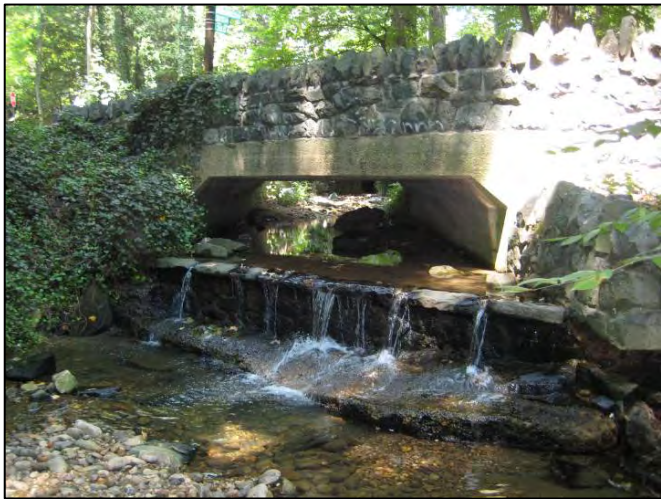
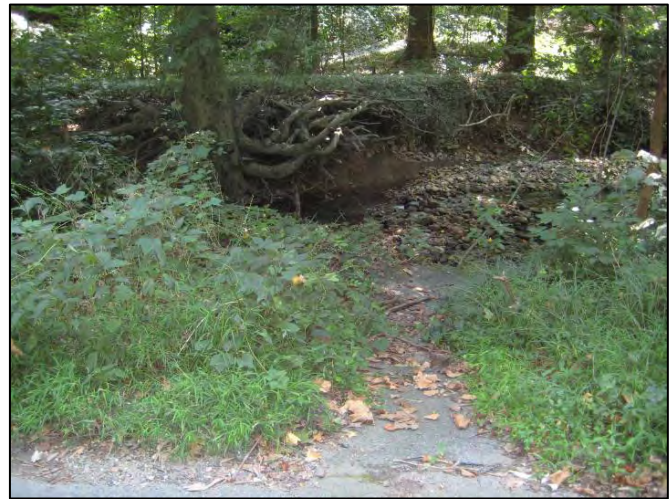
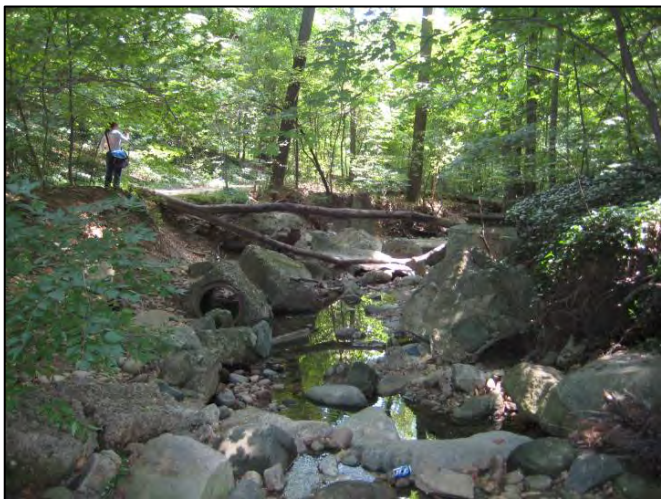
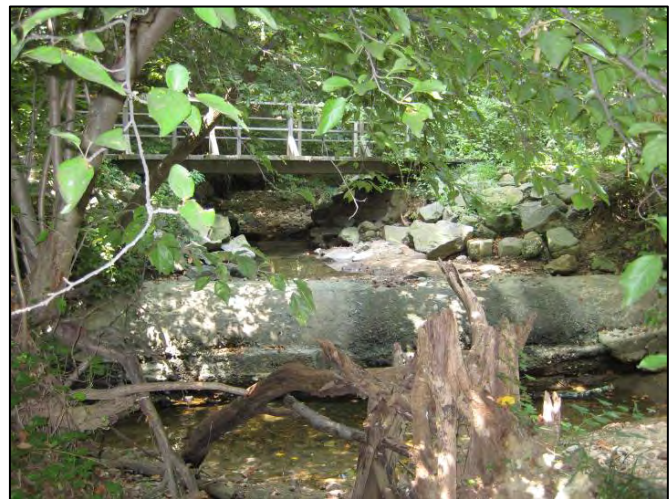
PROJECT_NUMBER RC_Stream_11
SITE_LOCATION St. Albans School - 3000 Wisconsin Ave NW

ADC_MAP_LOCATION 5527_J2&K2
OWNERSHIP Private
APPROXIMATE_LENGTH (Feet) 580
DESCRIPTION_OF_EXISTING_CONDITIONS Large wooded area with existing stream valley. Likely that stream has been piped.

PROJECT_DESCRIPTION Daylight first order stream in stream valley. Augment flow of stream with additional base flow from water infiltrated by coastal plain outfalls and bioretention for runoff from parking lot and campus roadways.

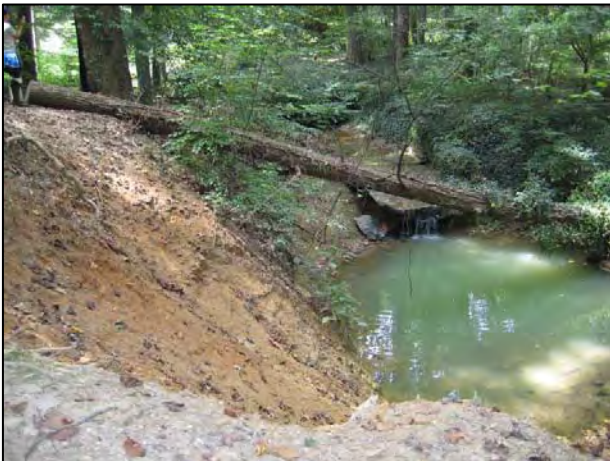
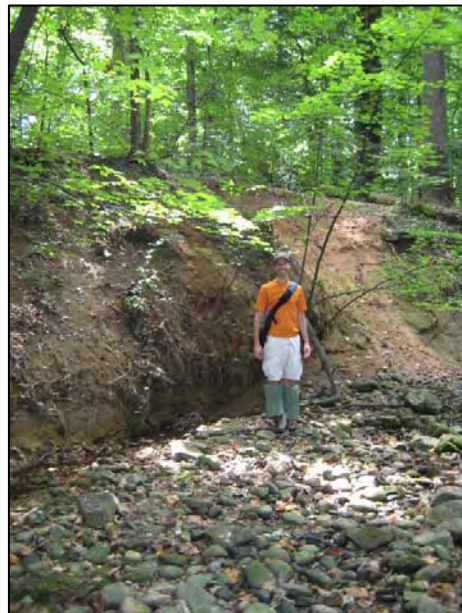
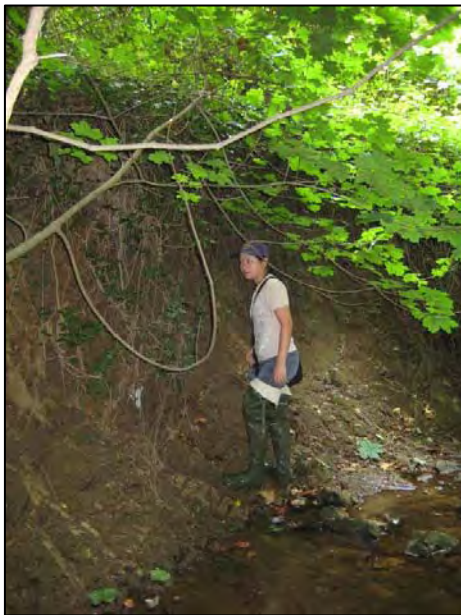
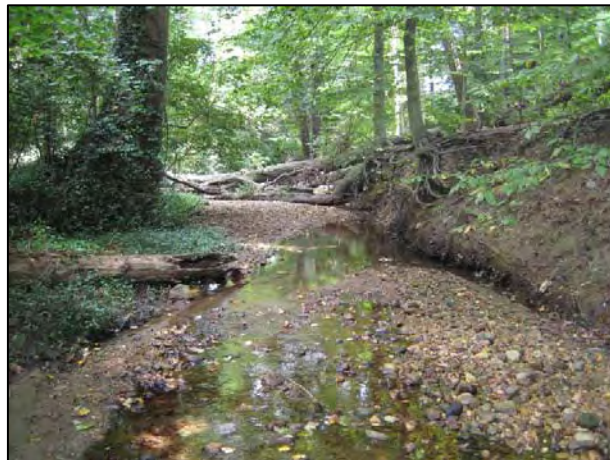
Wooded stream valley west of Connecticut Avenue NW. Stream is severely down cut with active erosion. Steep, unstable stream banks. Stream is piped to flow under Connecticut Avenue. Pipe is clogged and has created a wetland area.

Bioretention & regenerative stormwater conveyances for outfalls. Invasive removal and riparian buffer planting. Likely need for hardening banks. Comprehensive work for length of stream. Engineer lower area as a palustrine wetland and plant it.

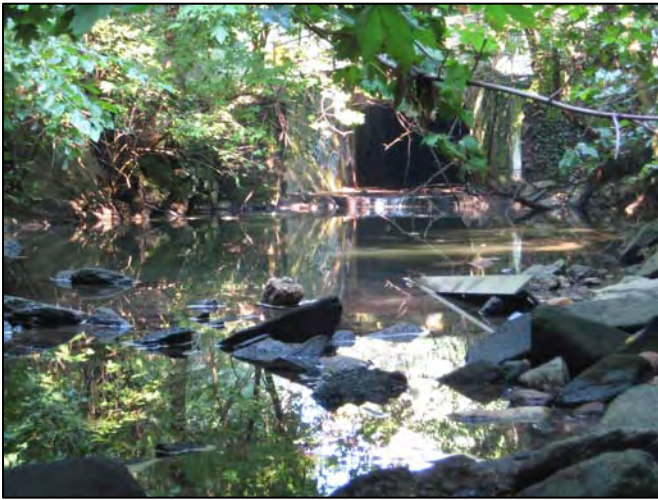
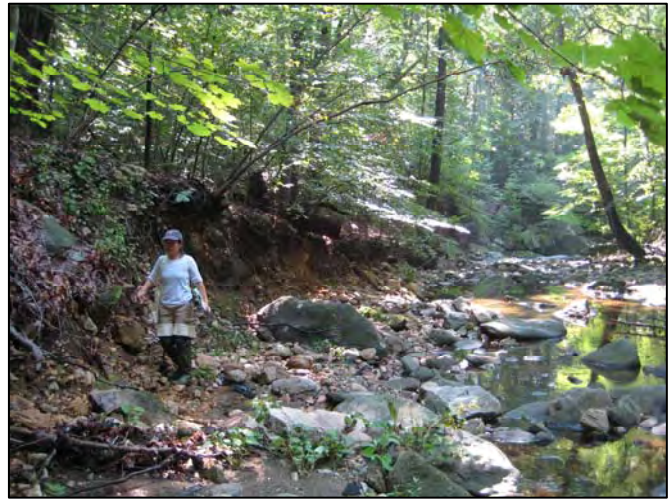
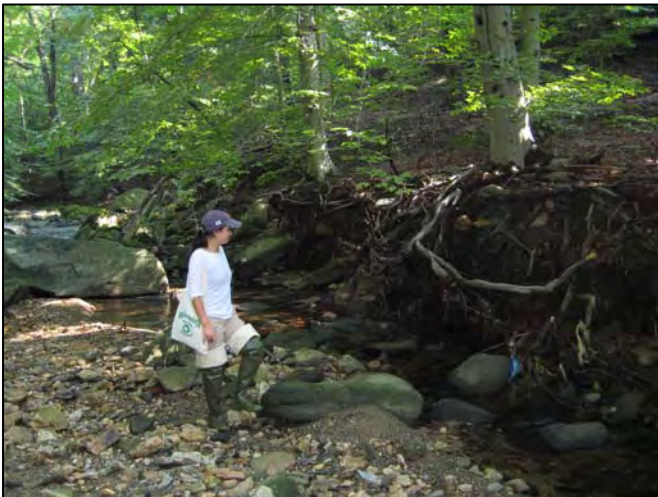
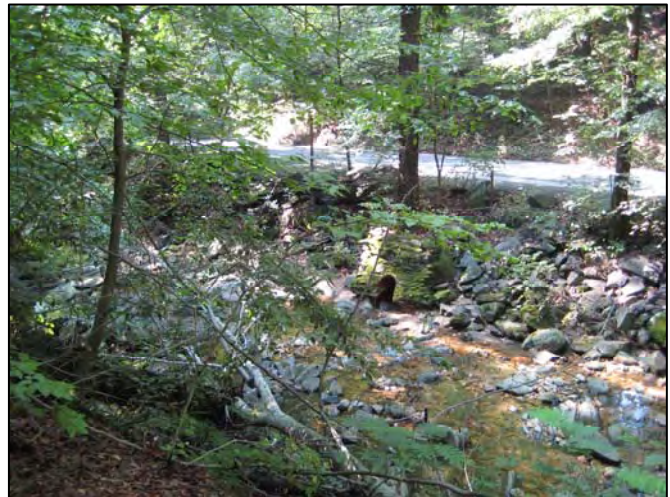
Stream down to bedrock for length. Soft banks with erosion on wooded side opposite roadway. Hardened banks on roadside for lower reaches. Collapsing in some locations.

Bioretention & regenerative stormwater conveyances for outfalls. Invasive removal and riparian buffer planting. Likely need for hardening banks, flow diversion to protect sewer infrastructure. Comprehensive work for length of stream.

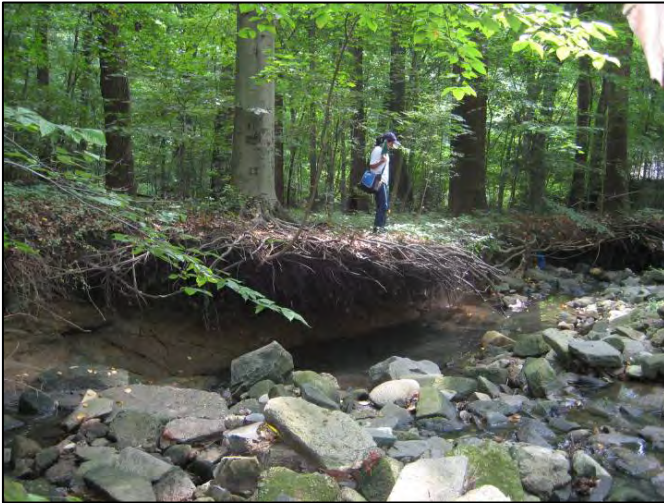
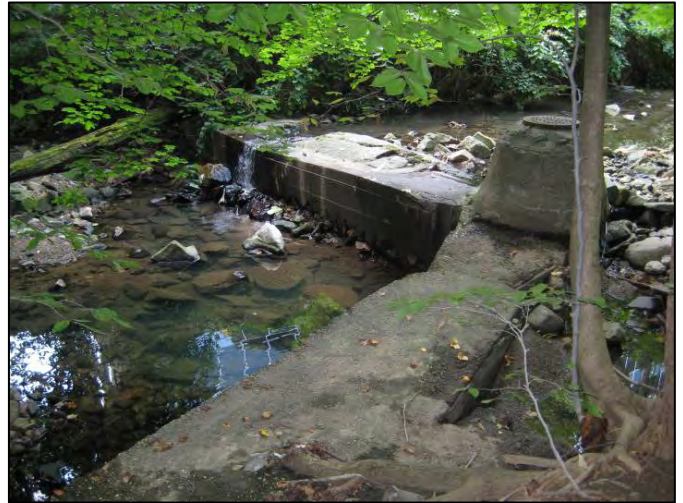
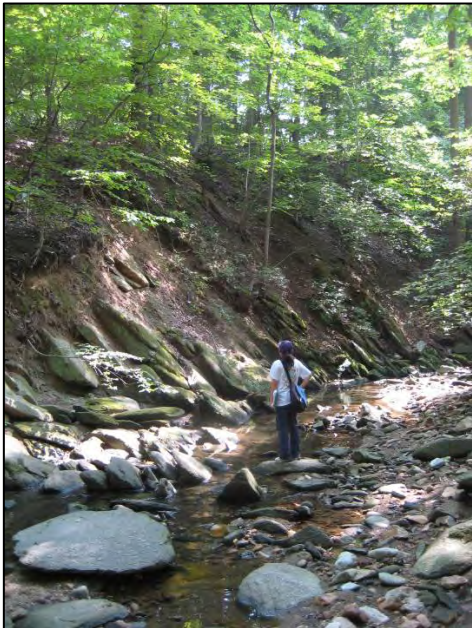
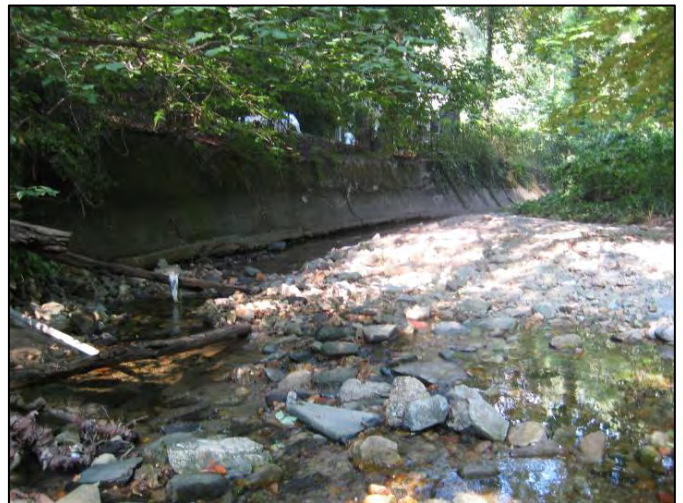
PROJECT_NUMBER	RC_Stream_17
SITE_LOCATION	Soapstone Creek - Connecticut Avenue NW and Albemarle Street NW to Broad Branch
ADC_MAP_LOCATION	5407_K9&5408_A9&B9
OWNERSHIP	Public
APPROXIMATE_LENGTH (Feet)	4532
DESCRIPTION_OF_EXISTING_CONDITIONS	Wooded stream valley east of Connecticut Avenue NW near Van Ness. Most densely developed area with a lot of stormwater. Stream is severely down cut with active erosion. Steep, unstable stream banks. Sewage smell at outfall.
PROJECT_DESCRIPTION	Bioretention & regenerative stormwater conveyances for outfalls. Likely need for some hardening of banks & flow deflection devices to protect sewer infrastructure. Comprehensive work for length of stream. Correct sewage leaks.
ESTIMATED_COST	\$4,532,300.00
PROJECT_RANKING_EDUCATION	High
PROJECT_RANKING_ENVIRONMENT	High
PROJECT_RANKING_INSTALLATION	High

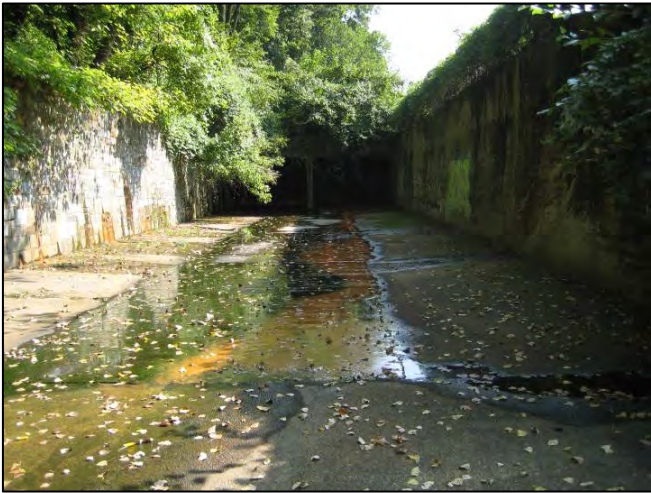
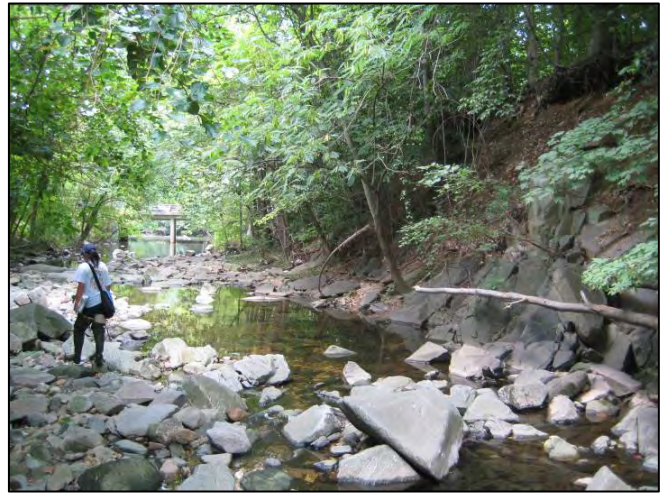
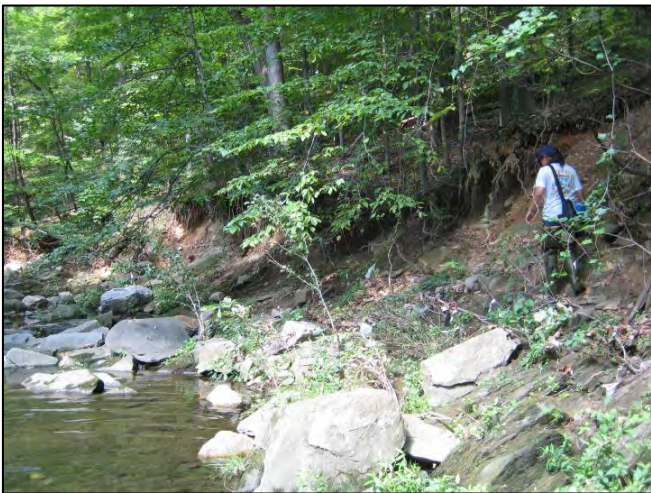
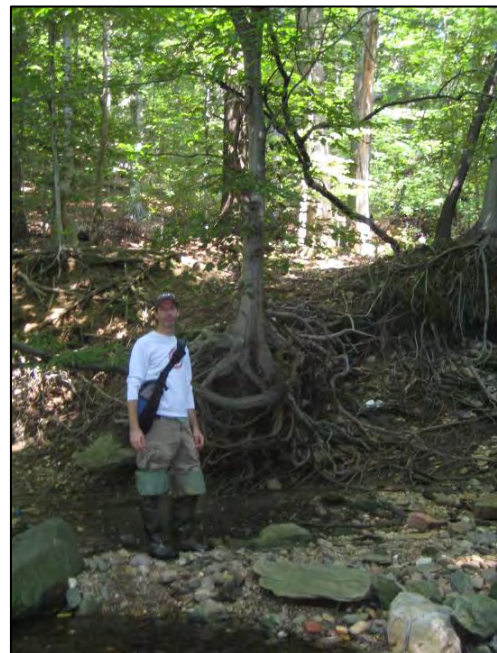
PROJECT_NUMBER	RC_Stream_18
SITE_LOCATION	Piney Branch - North of Piney Branch Parkway NW from 16th Street NW to Rock Creek
ADC_MAP_LOCATION	5528_C1&D1
OWNERSHIP	Public
APPROXIMATE_LENGTH (Feet)	2944
DESCRIPTION_OF_EXISTING_CONDITIONS	Stream emerges from pipe near intersection with 17th Street & Parkway. Stream down to bedrock for length. Predominantly hardened banks on roadside for length of stream. Collapsing in some locations. Outfall poured concrete pad for 100 yards.
PROJECT_DESCRIPTION	Bioretention & regenerative stormwater conveyances for outfalls into stream. Invasive removal and riparian buffer planting. Willow stakes in hardened banks, harden banks & flow diversion for soft banks. Comprehensive work for length of stream.
ESTIMATED_COST	\$2,943,810.00
PROJECT_RANKING_EDUCATION	High
PROJECT_RANKING_ENVIRONMENT	High
PROJECT_RANKING_INSTALLATION	High

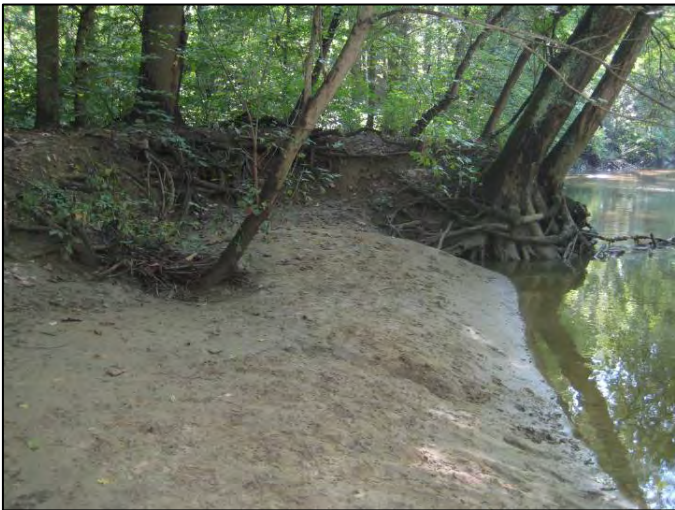
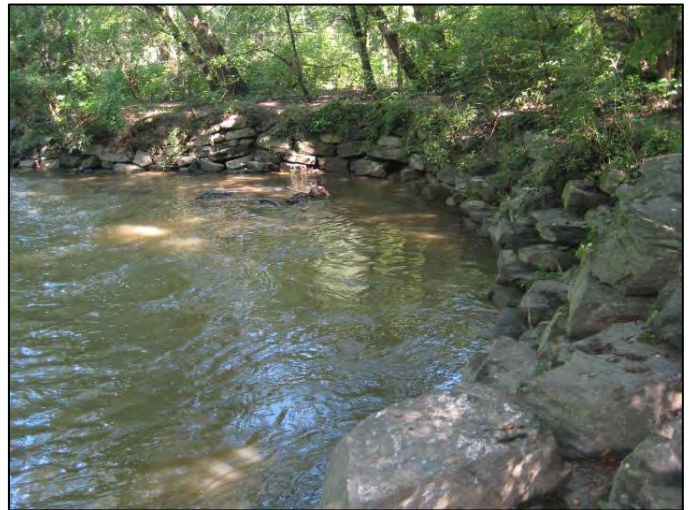
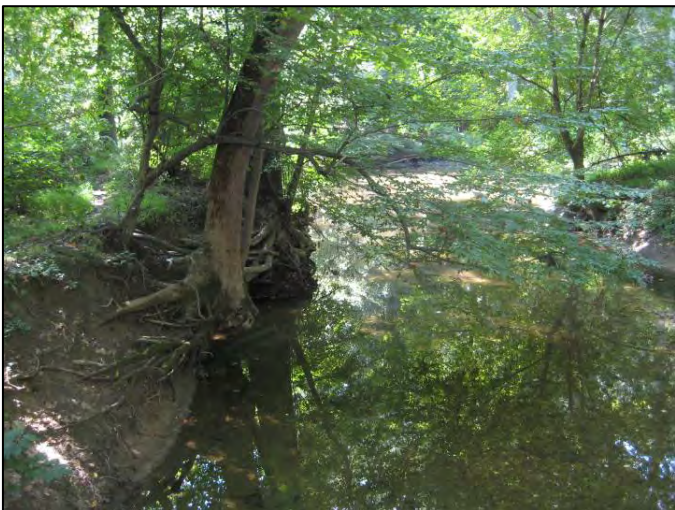
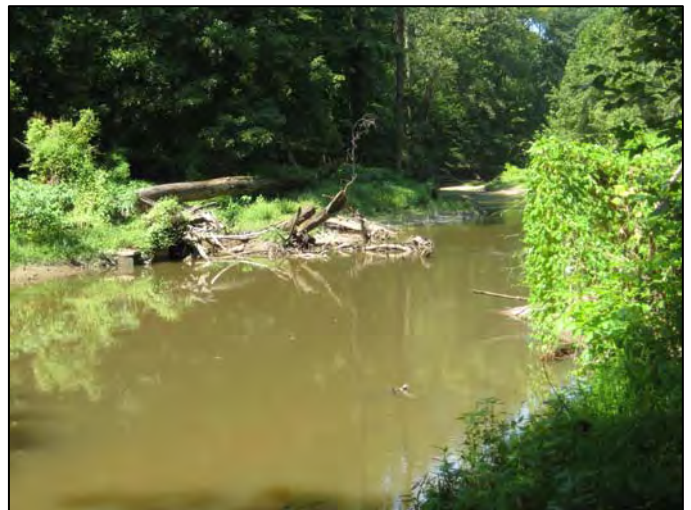
Forested stream valley with 2-lane road adjacent to stream for length of stream segment. Stream has mix of hardened bank structures and soft banks. Soft banks often show downcutting. Storm and sewer infrastructure present in stream valley.

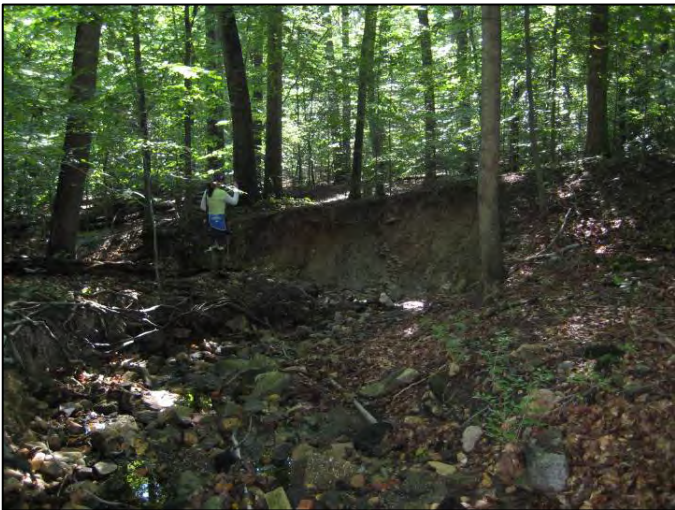
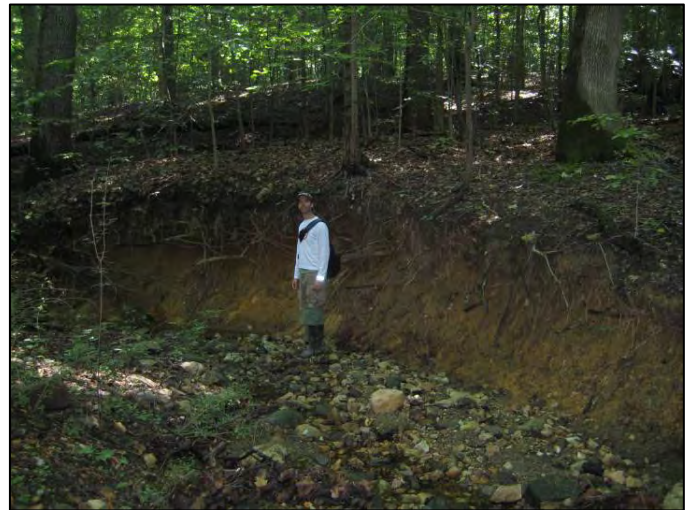
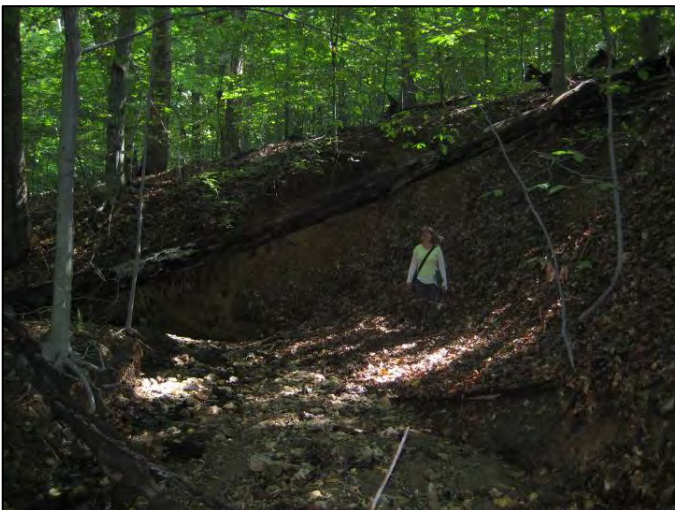
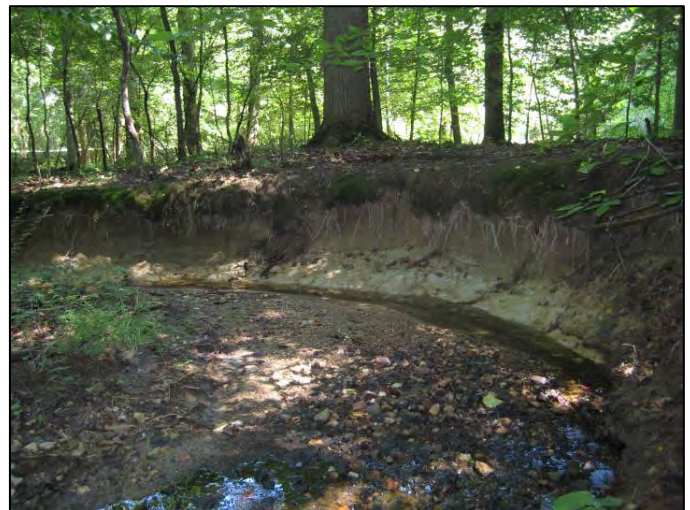
PROJECT_NUMBER	RC_Stream_20
SITE_LOCATION	Unnamed tributary to Rock Creek - Oregon Avenue NW and Daniel Lane NW to Rock Creek
ADC_MAP_LOCATION	5408_B3&C3
OWNERSHIP	Public
APPROXIMATE_LENGTH (Feet)	1837
DESCRIPTION_OF_EXISTING_CONDITIONS	Stormwater from Oregon Avenue and neighboring roadways drains into stream valley near Daniel Lane NW. Unnamed stream is highly incised and actively undercutting.
PROJECT_DESCRIPTION	Install regenerative stormwater conveyance at outfall from Oregon Avenue east of Daniel Lane NW. Comprehensive stream restoration for rest of stream valley.
ESTIMATED_COST	\$1,377,518.00
PROJECT_RANKING_EDUCATION	Medium
PROJECT_RANKING_ENVIRONMENT	High
PROJECT_RANKING_INSTALLATION	High

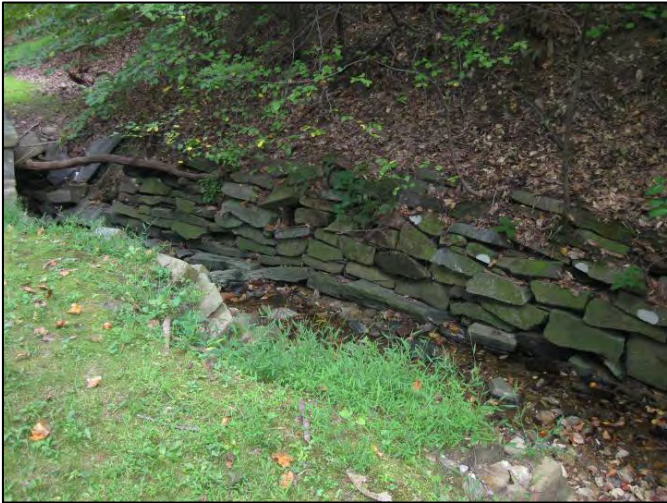
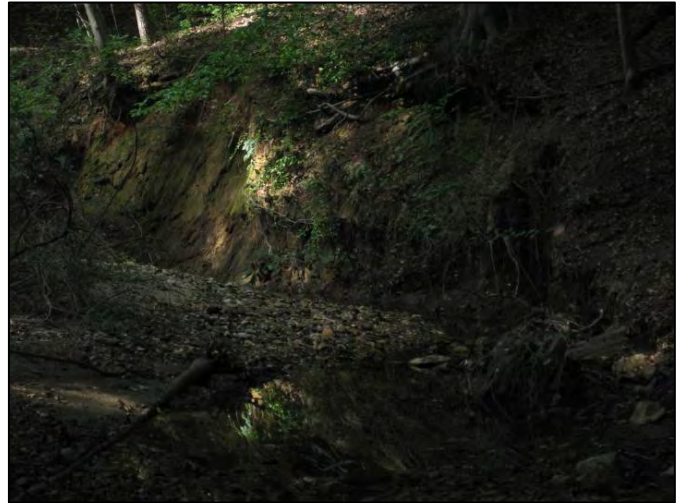
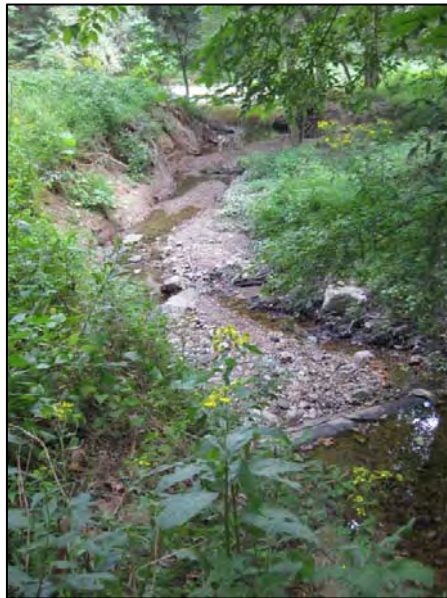
PROJECT_NUMBER	RC_Stream_21
SITE_LOCATION	Bingham Run - Bingham Road NW from Oregon Avenue NW to Rock Creek
ADC_MAP_LOCATION	5408B5&C5
OWNERSHIP	Public
APPROXIMATE_LENGTH (Feet)	2550
DESCRIPTION_OF_EXISTING_CONDITIONS	Stormwater from Nebraska Avenue, Oregon Avenue and neighboring area drains into Bingham Run at outfall at Bingham Drive NW. Bingham Run is highly incised and actively undercutting with several blockages to fish passage.
PROJECT_DESCRIPTION	Comprehensive stream restoration for stream involving a mixture of soft and hard structures to stabilize stream banks and protect infrastructure. Remove barriers to fish passage.
ESTIMATED_COST	\$1,912,178.00
PROJECT_RANKING_EDUCATION	High
PROJECT_RANKING_ENVIRONMENT	High
PROJECT_RANKING_INSTALLATION	High

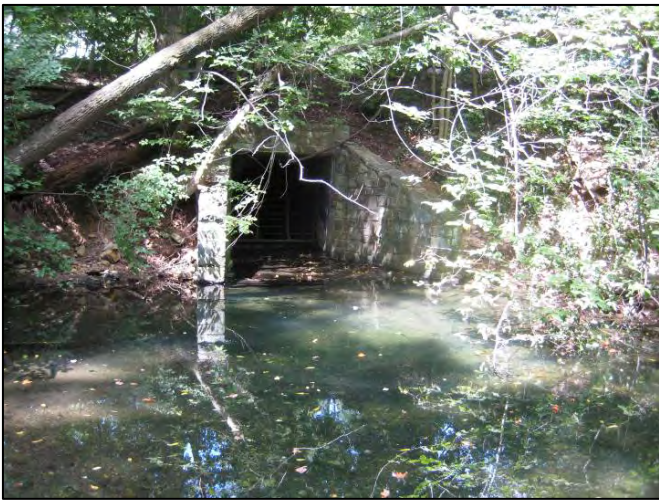
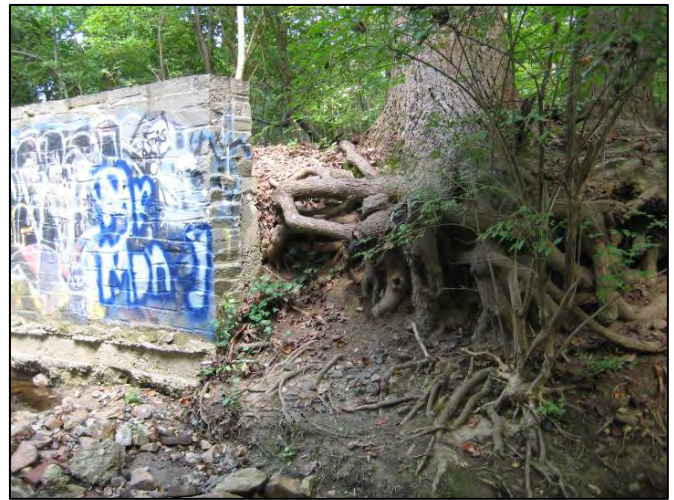
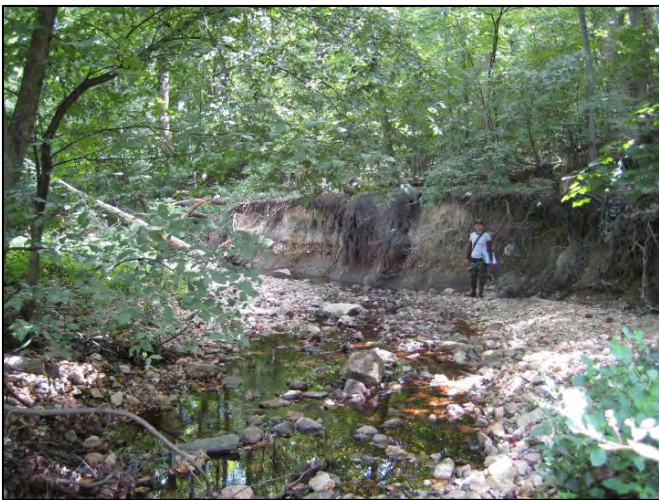
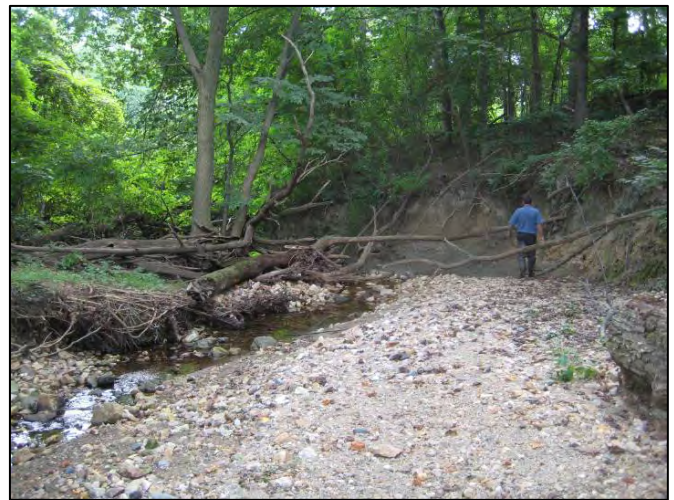
PROJECT_NUMBER	RC_Stream_22
SITE_LOCATION	Upper Pinehurst Branch - Western Avenue NW and Beech Street NW to Oregon Avenue NW
ADC_MAP_LOCATION	5408A4&B4
OWNERSHIP	Public
APPROXIMATE_LENGTH (Feet)	7423
DESCRIPTION_OF_EXISTING_CONDITIONS	Deeply incised stream from outfall at Western Avenue NW where stream comes above ground to Oregon Avenue. Narrow stream valley with adjacent roadways limits restoration potential. Some exposed sewer infrastructure and blockages to fish passage.
PROJECT_DESCRIPTION	Bioretention & regenerative stormwater conveyances for outfalls. Invasive removal and riparian buffer planting. Likely need for hardening banks, flow diversion to protect sewer & road infrastructure. Comprehensive work for length of stream.
ESTIMATED_COST	\$5,567,085.00
PROJECT_RANKING_EDUCATION	Medium
PROJECT_RANKING_ENVIRONMENT	High
PROJECT_RANKING_INSTALLATION	High

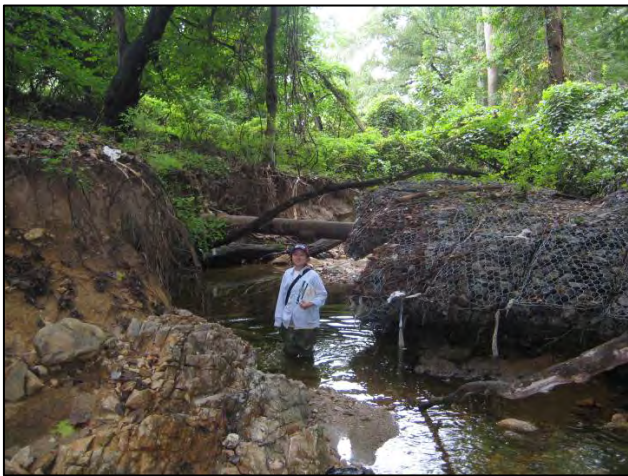
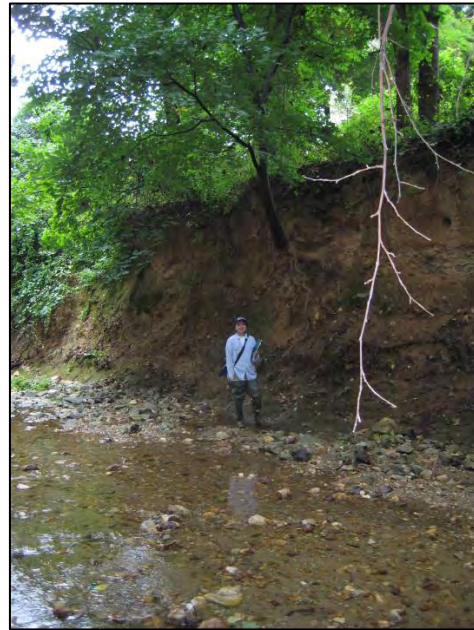
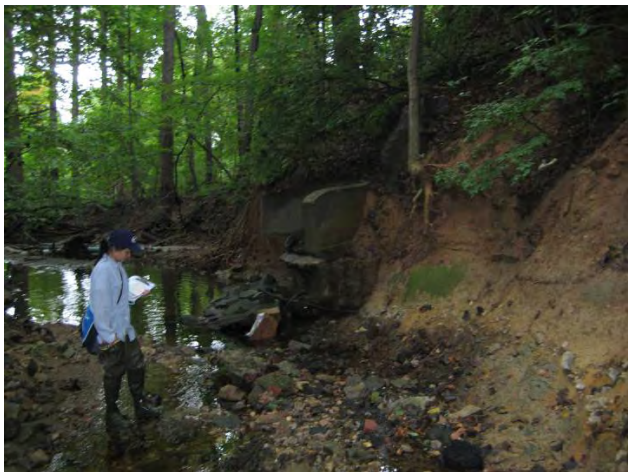
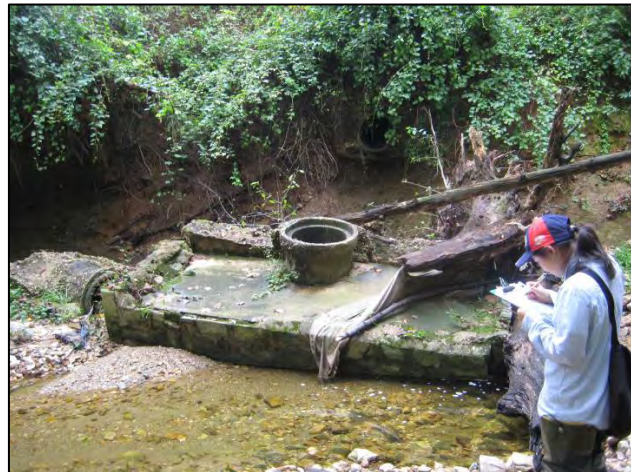
RC_Stream_28

Sediment from upstream Fenwick Branch settling north of Kalmia Street Bridge. Culvert under bridge undersized and clogged. Sediment in stream on top of clay base layer.

Redesign culvert under bridge to properly size it for flow. Potentially create wetland area upstream of bridge if won't create flooding problem. If so, remove sediment and use in upstream regenerative stormwater conveyances.

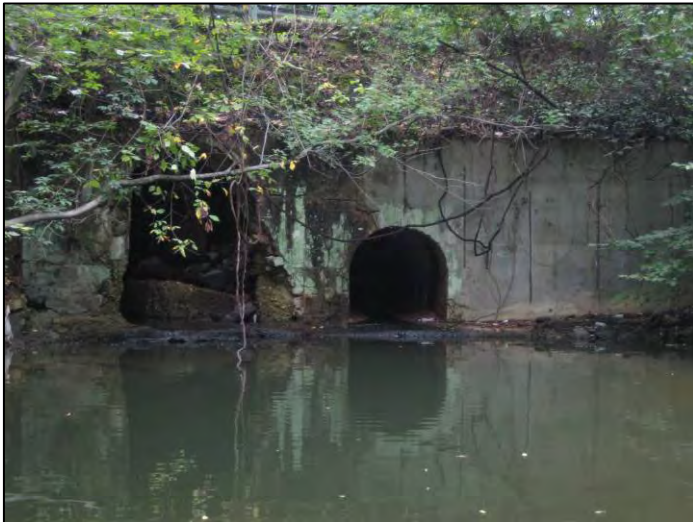
RC_Stream_29

Deeply incised stream with no current stabilization measures in place. Stream valley is wide but large amounts of stormwater from MD may limit restoration. Kalmia Bridge culvert blocks fish passage.

Bioretention & regenerative stormwater conveyances for outfalls. Invasive removal and riparian buffer planting. Likely need for hardening banks, flow diversion to protect sewer & road infrastructure. Comprehensive work for length of stream.

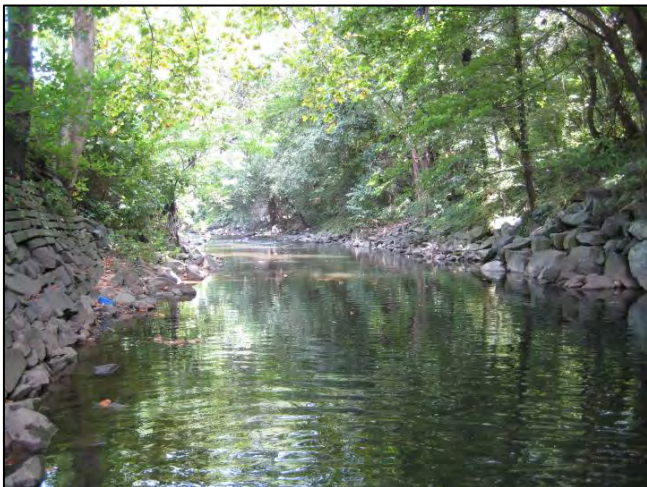
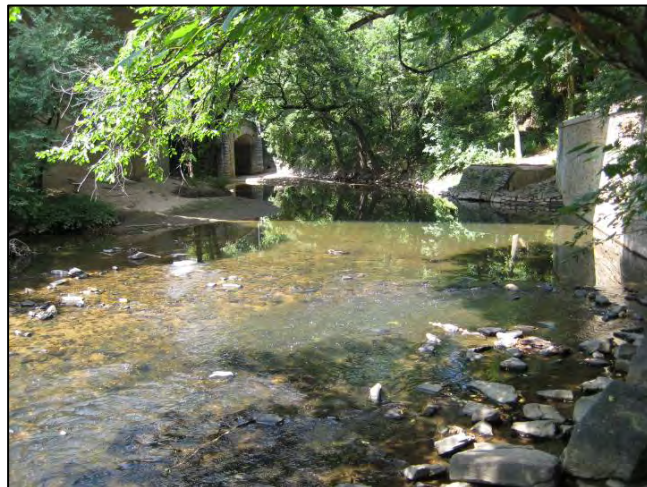
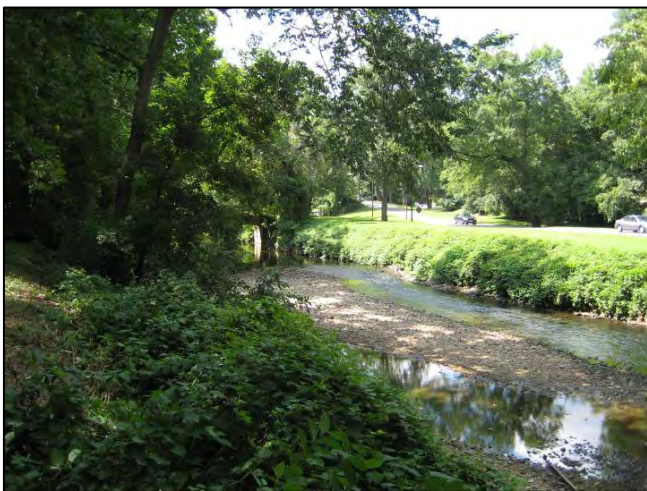
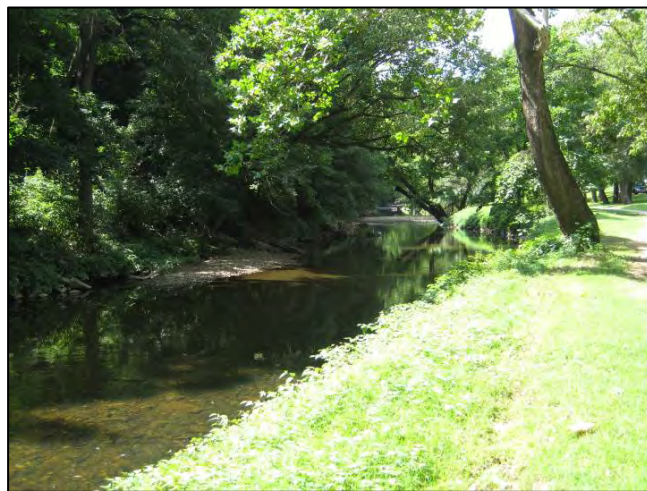
PROJECT_NUMBER	RC_Stream_35
SITE_LOCATION	Rock Creek main stem - Pennsylvania Avenue NW to the Potomac River
ADC_MAP_LOCATION	5528_A6
OWNERSHIP	Public
APPROXIMATE_LENGTH (Feet)	2198
DESCRIPTION_OF_EXISTING_CONDITIONS	Stream valley predominantly grass with 4 lane parkway adjacent to stream for length of stream segment. Stream predominantly hardened bank structures on both sides. Storm and sewer infrastructure present in stream valley.
PROJECT_DESCRIPTION	Predominantly restoration of hardened banks and flow diversion devices to protect infrastructure. Plant willow stakes in hardened structures and reforest grass areas.
ESTIMATED_COST	\$1,648,560.00
PROJECT_RANKING_EDUCATION	High
PROJECT_RANKING_ENVIRONMENT	High
PROJECT_RANKING_INSTALLATION	High
